Machine Id
728008
Component
Diesel Engine
Fluid
NOT GIVEN (12 QTS)

Customer Id: GFL073
Sample No.: GFL0069187
Lab Number: 05899633
Test Package: FLEET

OIL ANALYSIS REPORT

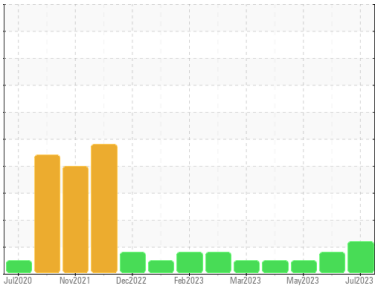
Sample Rating Trend

▲ Fuel Dilution

▲ Viscosity @ 100°C

Sample Status				**ABNORMAL**	ABNORMAL	NORMAL
Fuel	%	ASTM D3524	>5	▲ **4.4**	<1.0	<1.0
Visc @ 100°C	cSt	ASTM D445		▲ **12.4**	13.4	13.7

We advise that you check the fuel injection system. Resample at the next service interval to monitor.

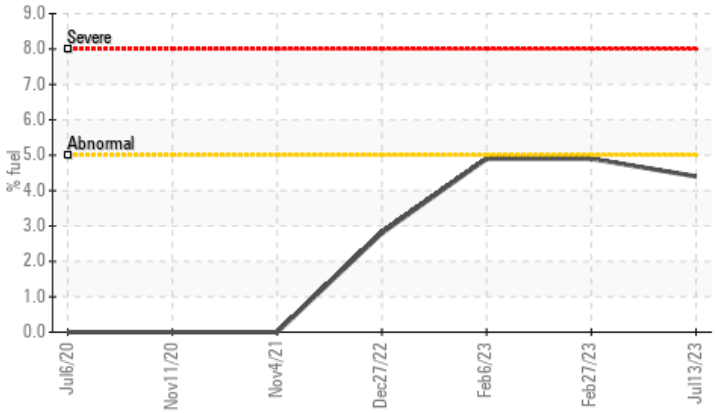
▲ Contamination
There is a moderate amount of fuel present in the oil.

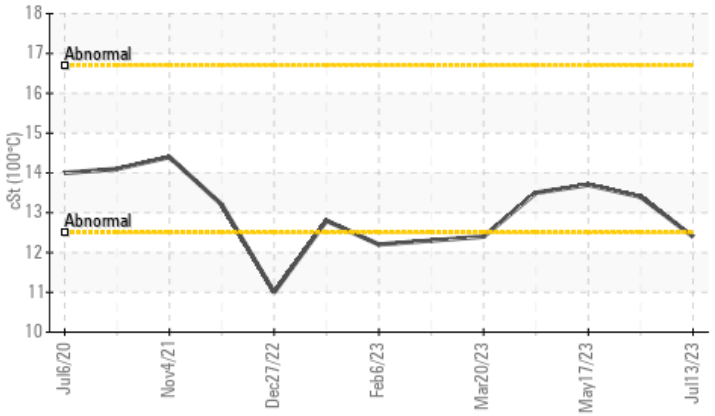
▲ Fluid Condition
Fuel is present in the oil and is lowering the viscosity. The BN result indicates that there is suitable alkalinity remaining in the oil.

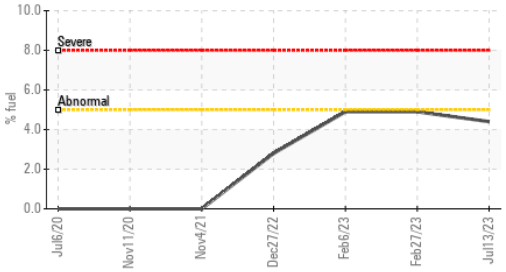
Fuel Dilution

CONTAMINANTS		method	limit/base	current	history1	history2
Silicon	ppm	ASTM D5185m	>25	**8**	5	6
Sodium	ppm	ASTM D5185m		**2**	0	2
Potassium	ppm	ASTM D5185m	>20	**2**	2	1
Fuel	%	ASTM D3524	>5	▲ **4.4**	<1.0	<1.0

▲ Recommendation
We advise that you check the fuel injection system. Resample at the next service interval to monitor.

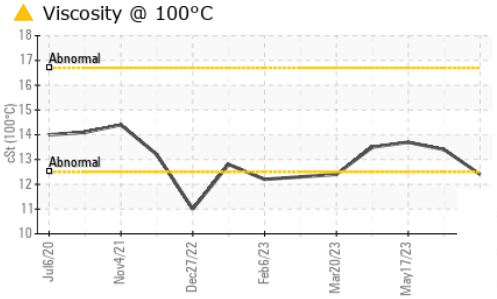
Viscosity @ 100°C

FLUID PROPERTIES		method	limit/base	current	history1	history2
Visc @ 100°C	cSt	ASTM D445		▲ **12.4**	13.4	13.7
