OIL ANALYSIS REPORT

Area
KEMP QUARRIES / RIVER VALLEY BACKBONE
Machine Id
WL088
Component
Hydraulic System
Fluid
MOBIL DELVAC 1300 SUPER15W40 (--- GAL)

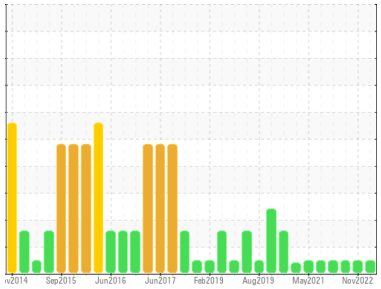
Sample Rating Trend

NORMAL

Wear
All component wear rates are normal.

Contamination
There is no indication of any contamination in the fluid.

Fluid Condition
The condition of the fluid is acceptable for the time in service.

Recommendation
Resample at the next service interval to monitor. (Customer Sample Comment: 6146)
