OIL DIAGNOSTICS

Area
[98391076]
Machine Id
KR-GR-003071 - DUMPER 3A (S/N GRIND A - 11513012)
Component
Hydraulic System
Fluid
AW HYDRAULIC OIL ISO 68 (--- GAL)

Customer Id: KRAKIR
Sample No.: PCA0102554
Lab Number: 05926086
Test Package: IND 2

OIL ANALYSIS REPORT

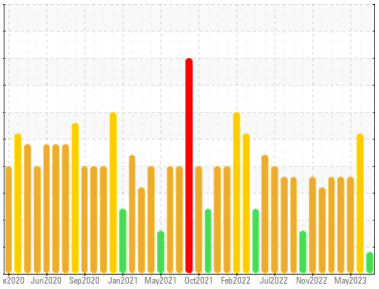
Sample Rating Trend

CONTAMINANT

Sample Status				**ATTENTION**	ABNORMAL	ABNORMAL
Appearance	scalar	*Visual	NORML	▲ **HAZY**	▲ HAZY	▲ HAZY

Resample at the next service interval to monitor.

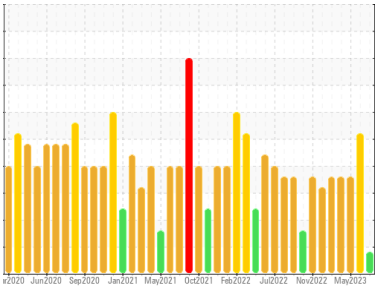
Sample Rating Trend

CONTAMINANT

Contamination
Appearance is hazy. The water content is negligible. The amount and size of particulates present in the system are acceptable. There is no indication of any contamination in the oil.

Recommendation
Resample at the next service interval to monitor.

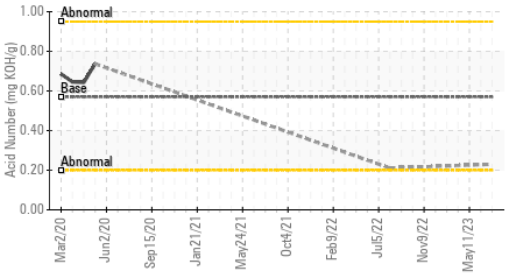
Fluid Condition
The AN level is acceptable for this fluid. The condition of the oil is suitable for further service.

FLUID DEGRADATION		method	limit/base	current	history1	history2
Acid Number (AN)	mg KOH/g	ASTM D8045	0.57	**0.23**	---	---

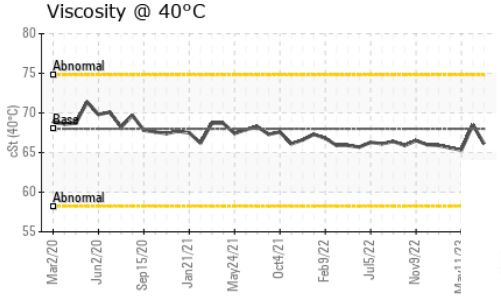
Viscosity @ 40°C

FLUID PROPERTIES		method	limit/base	current	history1	history2
Visc @ 40°C	cSt	ASTM D445	68	**66.1**	68.5	65.3

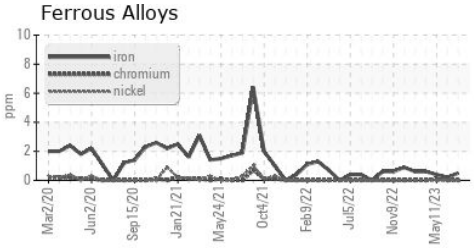
Ferrous Alloys

Wear
All component wear rates are normal.

WEAR METALS		method	limit/base	current	history1	history2
Iron	ppm	ASTM D5185m	>20	**<1**	<1	<1
Chromium	ppm	ASTM D5185m	>20	**0**	0	<1
Nickel	ppm	ASTM D5185m	>20	**0**	0	0
Titanium	ppm	ASTM D5185m		**0**	0	0
Silver	ppm	ASTM D5185m		**0**	0	0
Aluminum	ppm	ASTM D5185m	>20	**0**	0	0
Lead	ppm	ASTM D5185m	>20	**0**	0	0
Copper	ppm	ASTM D5185m	>20	**0**	0	0
Tin	ppm	ASTM D5185m	>20	**0**	0	<1
Vanadium	ppm	ASTM D5185m		**0**	0	0
Cadmium	ppm	ASTM D5185m		**0**	0	0
