# PROBLEM SUMMARY

Machine Id
**727103-361675**
Component
**Diesel Engine**
Fluid
**PETRO CANADA DURON SHP 15W40 (--- GAL)**

# OIL ANALYSIS REPORT

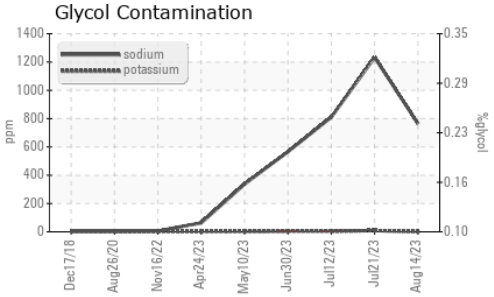
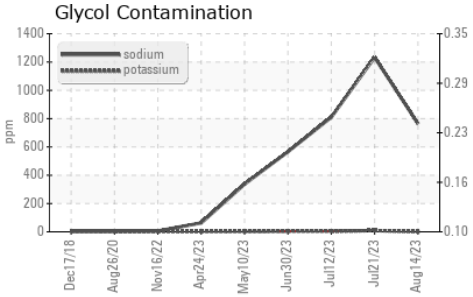
Glycol Contamination

**Contamination**
Sodium and/or potassium levels are high.

| CONTAMINANTS | | method | limit/base | current | history1 | history2 |
|---|---|---|---|---|---|---|
| Sodium | ppm | ASTM D5185m | | ▲ **764** | ▲ 1233 | ▲ 810 |
| Glycol | % | *ASTM D2982 | | **NEG** | NEG | ⬢ 0.10 |

**Recommendation**
We advise that you check for the source of the coolant leak. Check for low coolant level. We recommend an early resample to monitor this condition.
