OIL DIAGNOSTICS

Area
SCOF [98406069]
Machine Id
6320 EAST
Component
Gearbox
Fluid
GEAR OIL ISO 460 (--- GAL)

Customer Id: KRASPRMO
Sample No.: PCA0100111
Lab Number: 05937189
Test Package: IND 2

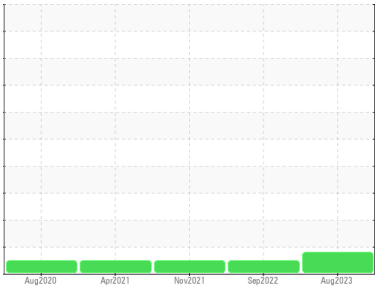
Sample Rating Trend

Sample Status				**ATTENTION**	NORMAL	NORMAL
Particles >6µm		ASTM D7647	>320	▲ **387**	30	83
Oil Cleanliness		ISO 4406 (c)	>17/15/13	▲ **17/16/13**	15/12/9	15/14/11

No corrective action is recommended at this time. The oil filtered at the time of sampling has been noted. Resample at the next service interval to monitor.

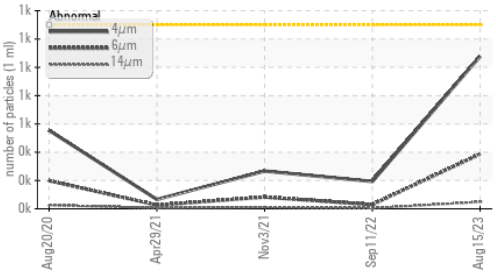
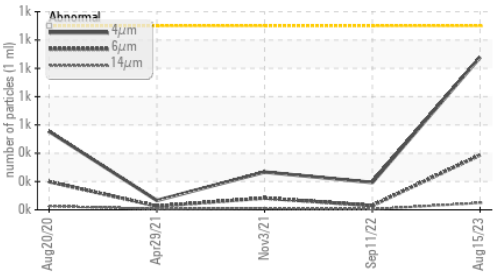
Particle Trend

There is a moderate amount of silt (particulates < 14 microns in size) present in the oil.

FLUID CLEANLINESS		method	limit/base	current	history1	history2
Particles >4µm		ASTM D7647	>1300	**1078**	193	267
Particles >6µm		ASTM D7647	>320	▲ **387**	30	83
Particles >14µm		ASTM D7647	>80	**49**	4	11
Particles >21µm		ASTM D7647	>20	**14**	2	3
Particles >38µm		ASTM D7647	>4	**2**	0	0
Particles >71µm		ASTM D7647	>3	**2**	0	0
Oil Cleanliness		ISO 4406 (c)	>17/15/13	▲ **17/16/13**	15/12/9	15/14/11

No corrective action is recommended at this time. The oil filtered at the time of sampling has been noted. Resample at the next service interval to monitor.

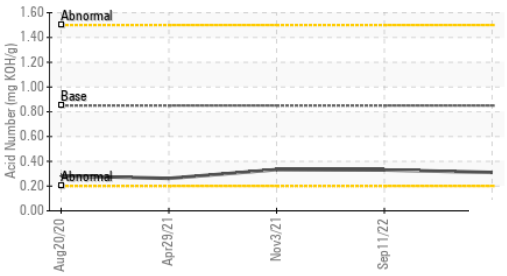
Acid Number

The AN level is acceptable for this fluid. The condition of the oil is suitable for further service.

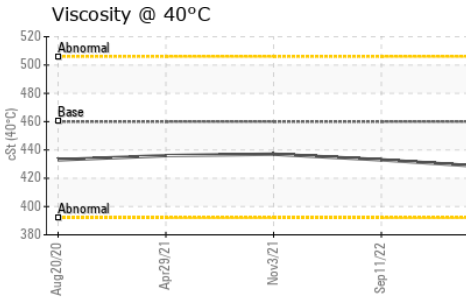
Viscosity @ 40°C

FLUID PROPERTIES		method	limit/base	current	history1	history2
Visc @ 40°C	cSt	ASTM D445	460	**428**	433	437
