PROBLEM SUMMARY

Machine Id
822040-101255
Component
Diesel Engine
Fluid
PETRO CANADA DURON SHP 15W40 (--- GAL)

OIL ANALYSIS REPORT

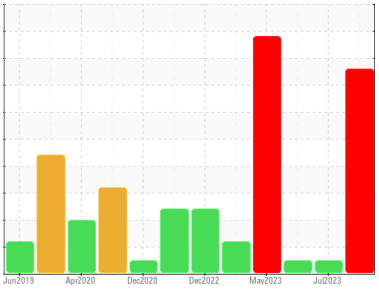
Sample Rating Trend

GLYCOL

Sample Status				SEVERE	NORMAL	NORMAL
Silicon	ppm	ASTM D5185m	>20	▲ **24**	11	5
Sodium	ppm	ASTM D5185m		▲ **1425**	35	9
Fuel	%	ASTM D3524	>5	⬢ **13.2**	<1.0	0.4
Glycol	%	*ASTM D2982		▲ **0.10**	NEG	NEG
Visc @ 100°C	cSt	ASTM D445	15.4	▲ **11.5**	13.9	14.1

We advise that you check the fuel injection system. We advise that you check for the source of the coolant leak. We recommend that you drain the oil and perform a filter service on this component if not already done. We recommend an early resample to monitor this condition.

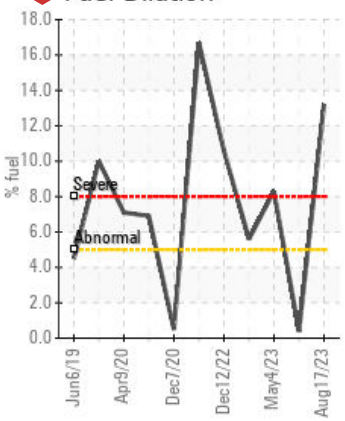
Fuel Dilution

Contamination
Sodium and/or potassium levels are high. Test for glycol is positive. There is a high amount of fuel present in the oil.

Fluid Condition
Fuel is present in the oil and is lowering the viscosity. The BN result indicates that there is suitable alkalinity remaining in the oil. The oil is no longer serviceable due to the presence of contaminants.

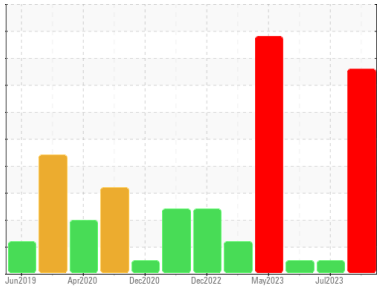
Sample Rating Trend

GLYCOL

Recommendation
We advise that you check the fuel injection system. We advise that you check for the source of the coolant leak. We recommend that you drain the oil and perform a filter service on this component if not already done. We recommend an early resample to monitor this condition.

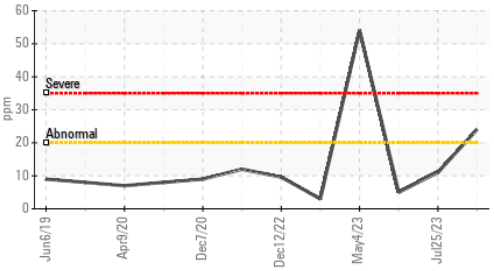
Silicon (ppm)

CONTAMINANTS		method	limit/base	current	history1	history2
Silicon	ppm	ASTM D5185m	>20	▲ **24**	11	5
Sodium	ppm	ASTM D5185m		▲ **1425**	35	9
Potassium	ppm	ASTM D5185m	>20	**7**	7	1
Fuel	%	ASTM D3524	>5	● **13.2**	<1.0	0.4
Glycol	%	*ASTM D2982		▲ **0.10**	NEG	NEG

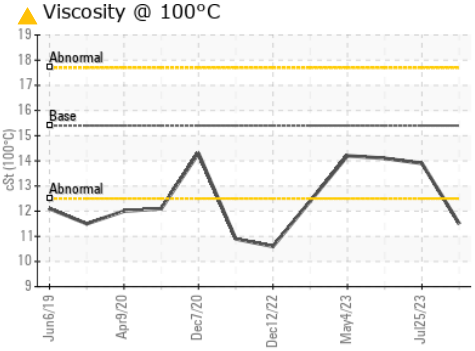
Viscosity @ 100°C

FLUID PROPERTIES		method	limit/base	current	history1	history2
Visc @ 100°C	cSt	ASTM D445	15.4	▲ **11.5**	13.9	14.1
