OIL DIAGNOSTICS

Area
NAT CUTS [98374507 PRESAMPLE]
Machine Id
LINE 12 CUBER
Component
Hydraulic System
Fluid
AW HYDRAULIC OIL ISO 46 (--- GAL)

OIL ANALYSIS REPORT

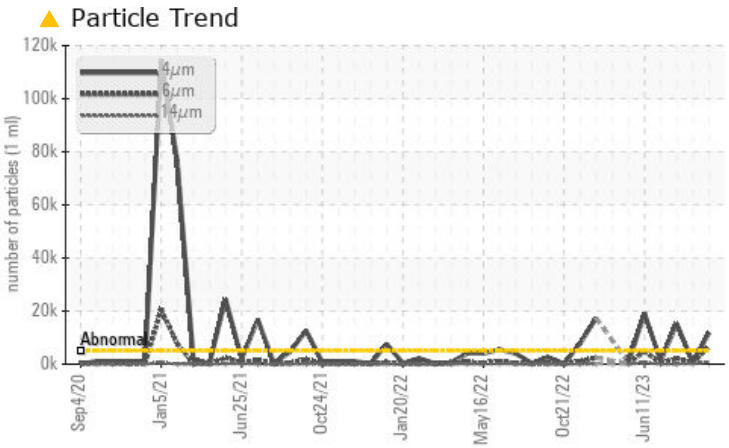
COMPONENT CONDITION SUMMARY

Sample Status				ABNORMAL	NORMAL	ABNORMAL
Particles >4µm		ASTM D7647	>5000	▲ **11819**	582	▲ 15217
Particles >6µm		ASTM D7647	>1300	▲ **6837**	383	▲ 2162
Particles >14µm		ASTM D7647	>320	▲ **842**	138	38
Particles >21µm		ASTM D7647	>80	▲ **116**	31	5
Oil Cleanliness		ISO 4406 (c)	>19/17/15	▲ **21/20/17**	16/16/14	▲ 21/18/12

Contamination
There is a high amount of particulates present in the oil.

We recommend you service the filters on this component if applicable. Resample at the next service interval to monitor.

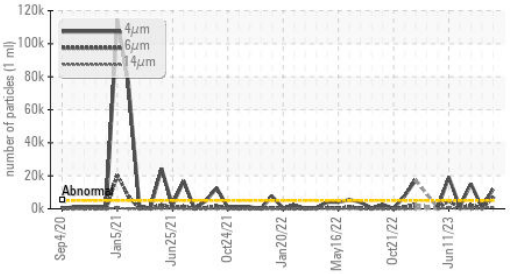
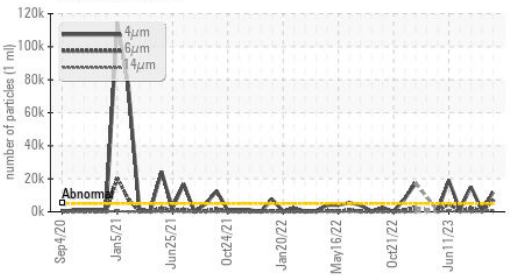
Particle Trend

FLUID CLEANLINESS		method	limit/base	current	history1	history2
Particles >4µm		ASTM D7647	>5000	▲ **11819**	582	▲ 15217
Particles >6µm		ASTM D7647	>1300	▲ **6837**	383	▲ 2162
Particles >14µm		ASTM D7647	>320	▲ **842**	138	38
Particles >21µm		ASTM D7647	>80	▲ **116**	31	5
Particles >38µm		ASTM D7647	>20	**0**	0	0
Particles >71µm		ASTM D7647	>4	**0**	0	0
Oil Cleanliness		ISO 4406 (c)	>19/17/15	▲ **21/20/17**	16/16/14	▲ 21/18/12

Recommendation
We recommend you service the filters on this component if applicable. Resample at the next service interval to monitor.
