OIL DIAGNOSTICS

Area
SCOF [98467500]
Machine Id
CURD BREAKER 2
Component
Gearbox
Fluid
GEAR OIL ISO 220 (--- GAL)

OIL ANALYSIS REPORT

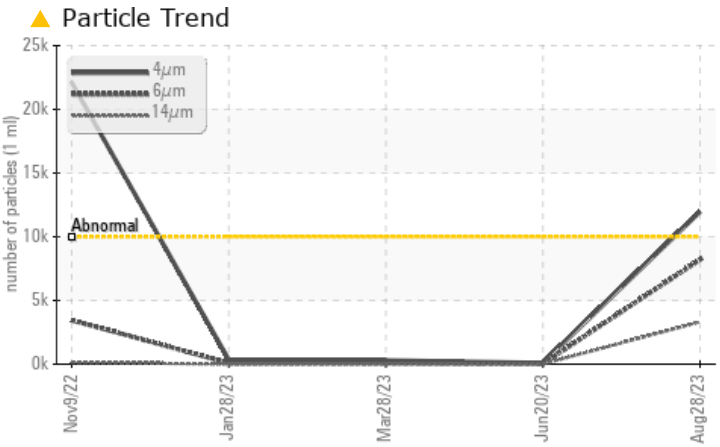
COMPONENT CONDITION SUMMARY

Sample Status				ABNORMAL	NORMAL	NORMAL
Particles >4µm		ASTM D7647	>10000	▲ **11954**	95	296
Particles >6µm		ASTM D7647	>2500	▲ **8205**	30	78
Particles >14µm		ASTM D7647	>640	▲ **3317**	5	11
Particles >21µm		ASTM D7647	>160	▲ **1703**	2	3
Particles >38µm		ASTM D7647	>40	▲ **263**	2	0
Particles >71µm		ASTM D7647	>10	▲ **55**	2	0
Oil Cleanliness		ISO 4406 (c)	>20/18/16	▲ **21/20/19**	14/12/10	15/13/11

Contamination
There is a high amount of particulates present in the oil.

We recommend you service the filters on this component if applicable. Resample at the next service interval to monitor.

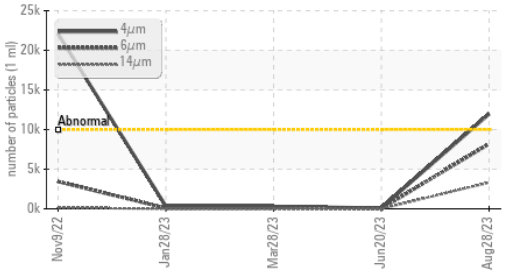
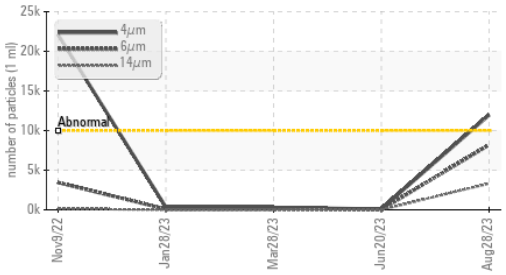
Particle Trend

FLUID CLEANLINESS		method	limit/base	current	history1	history2
Particles >4µm		ASTM D7647	>10000	▲ **11954**	95	296
Particles >6µm		ASTM D7647	>2500	▲ **8205**	30	78
Particles >14µm		ASTM D7647	>640	▲ **3317**	5	11
Particles >21µm		ASTM D7647	>160	▲ **1703**	2	3
Particles >38µm		ASTM D7647	>40	▲ **263**	2	0
Particles >71µm		ASTM D7647	>10	▲ **55**	2	0
Oil Cleanliness		ISO 4406 (c)	>20/18/16	▲ **21/20/19**	14/12/10	15/13/11

Recommendation
We recommend you service the filters on this component if applicable. Resample at the next service interval to monitor.
