# PROBLEM SUMMARY

Machine Id
**729045-361500**
Component
**Diesel Engine**
Fluid
**PETRO CANADA DURON SHP 15W40 (--- GAL)**

# OIL ANALYSIS REPORT

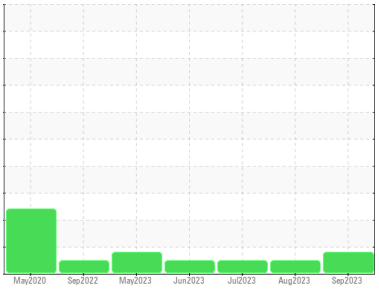
**Sample Rating Trend**

▲ Ferrous Alloys

| Sample Status | | | | **ABNORMAL** | NORMAL | NORMAL |
|---|---|---|---|---|---|---|
| Nickel | ppm | ASTM D5185m | >5 | ▲ **8** | 6 | 6 |

**Wear**
Valve wear is indicated. All other component wear rates are normal.

No corrective action is recommended at this time.
Resample at the next service interval to monitor.

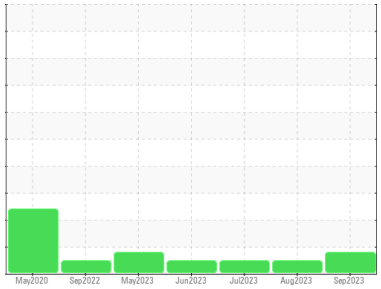
Sample Rating Trend

| WEAR METALS | | method | limit/base | current | history1 | history2 |
|---|---|---|---|---|---|---|
| Nickel | ppm | ASTM D5185m | >5 | ▲ **8** | 6 | 6 |

**Recommendation**
No corrective action is recommended at this time. Resample at the next service interval to monitor.
