Customer Id: GFL865
Sample No.: GFL0093270
Lab Number: 05964422
Test Package: FLEET

OIL ANALYSIS REPORT

Machine Id
727090-361682
Component
Diesel Engine
Fluid
PETRO CANADA DURON SHP 15W40 (--- GAL)

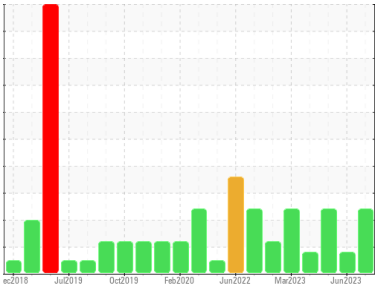
Sample Rating Trend

FUEL

Sample Status				SEVERE	ABNORMAL	SEVERE
Fuel	%	ASTM D3524	>5	**10.1**	5.7	10.8
Visc @ 100°C	cSt	ASTM D445	15.4	**12.9**	13.6	12.4

We advise that you check the fuel injection system. Oil and filter change at the time of sampling has been noted. We recommend an early resample to monitor this condition.

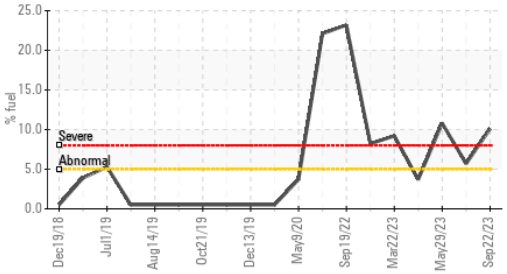
Fuel Dilution

Contamination
There is a high amount of fuel present in the oil.

CONTAMINANTS		method	limit/base	current	history1	history2
Silicon	ppm	ASTM D5185m	>25	**9**	3	5
Sodium	ppm	ASTM D5185m		**13**	7	12
Potassium	ppm	ASTM D5185m	>20	**2**	1	1
Fuel	%	ASTM D3524	>5	**10.1**	5.7	10.8

Recommendation
We advise that you check the fuel injection system. Oil and filter change at the time of sampling has been noted. We recommend an early resample to monitor this condition.

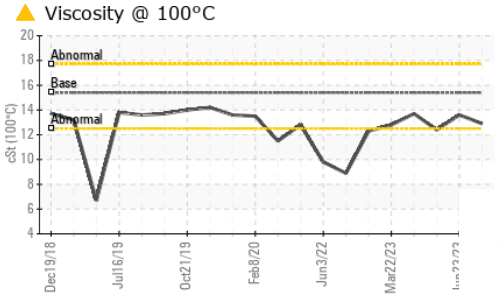
Viscosity @ 100°C

Fluid Condition
Fuel is present in the oil and is lowering the viscosity. The BN result indicates that there is suitable alkalinity remaining in the oil.

FLUID PROPERTIES		method	limit/base	current	history1	history2
Visc @ 100°C	cSt	ASTM D445	15.4	▲ **12.9**	13.6	▲ 12.4

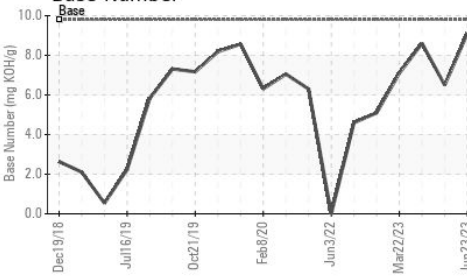
FLUID DEGRADATION		method	limit/base	current	history1	history2
Oxidation	Abs/.1mm	*ASTM D7414	>25	**26.3**	18.6	24.0
Base Number (BN)	mg KOH/g	ASTM D2896	9.8	**6.3**	9.1	6.5
