OIL DIAGNOSTICS

Area
[98559376]
Machine Id
KR-GR-003118 - CONDIMENT DUMPER (S/N STUFF A - 11513097)
Component
Hydraulic System
Fluid
AW HYDRAULIC OIL ISO 68 (10 GAL)

OIL ANALYSIS REPORT

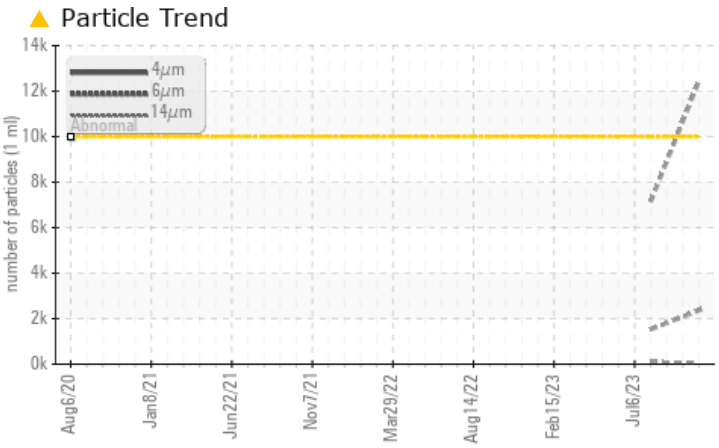
COMPONENT CONDITION SUMMARY

Sample Status				ATTENTION	ABNORMAL	ABNORMAL
Particles >4µm		ASTM D7647	>10000	▲ **12456**	---	---
Oil Cleanliness		ISO 4406 (c)	>20/18/16	▲ **21/18/14**	---	---

No corrective action is recommended at this time.
Resample at the next service interval to monitor.

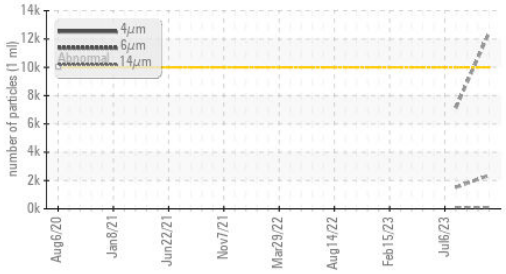
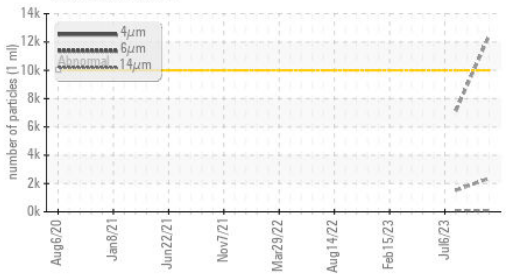
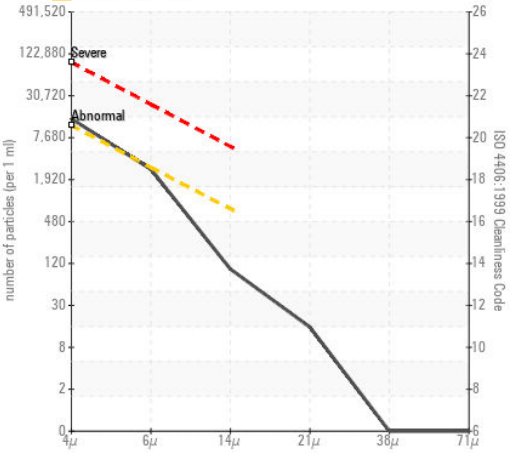
Contamination
There is a moderate amount of silt (particulates < 14 microns in size) present in the oil.

FLUID CLEANLINESS		method	limit/base	current	history1	history2
Particles >4µm		ASTM D7647	>10000	▲ **12456**	---	---
Particles >6µm		ASTM D7647	>2500	**2367**	---	---
Particles >14µm		ASTM D7647	>640	**88**	---	---
Particles >21µm		ASTM D7647	>160	**13**	---	---
Particles >38µm		ASTM D7647	>40	**0**	---	---
Particles >71µm		ASTM D7647	>10	**0**	---	---
Oil Cleanliness		ISO 4406 (c)	>20/18/16	▲ **21/18/14**	---	---

Recommendation
No corrective action is recommended at this time. Resample at the next service interval to monitor.
