OIL DIAGNOSTICS

Area
[98575017]
Machine Id
KR-GR-003114 - EAST DUMPER (S/N MIX D - 11513073)
Component
Hydraulic System
Fluid
AW HYDRAULIC OIL ISO 68 (--- GAL)

OIL ANALYSIS REPORT

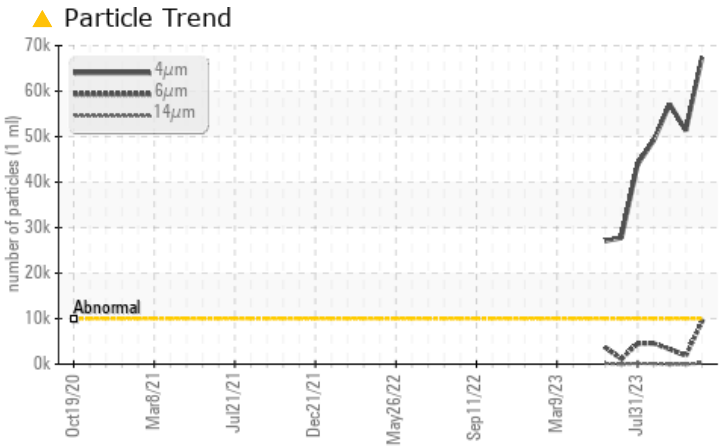
COMPONENT CONDITION SUMMARY

Sample Status				ABNORMAL	ABNORMAL	ABNORMAL
Particles >4µm		ASTM D7647	>10000	▲ **67408**	▲ 51322	▲ 57131
Particles >6µm		ASTM D7647	>2500	▲ **9370**	1866	▲ 3293
Oil Cleanliness		ISO 4406 (c)	>20/18/16	▲ **23/20/15**	▲ 23/18/11	▲ 23/19/10

We recommend you service the filters on this component if applicable. Resample at the next service interval to monitor.

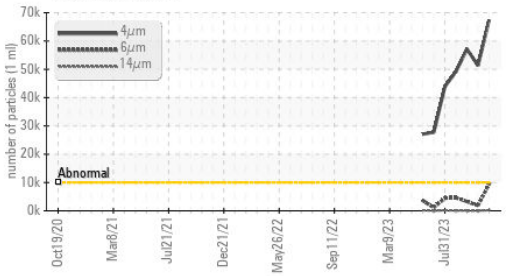
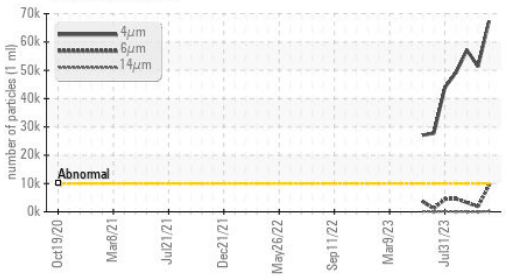
Particle Trend

Contamination
There is a high amount of silt (particulates < 14 microns in size) present in the oil.

FLUID CLEANLINESS		method	limit/base	current	history1	history2
Particles >4µm		ASTM D7647	>10000	▲ **67408**	▲ 51322	▲ 57131
Particles >6µm		ASTM D7647	>2500	▲ **9370**	1866	▲ 3293
Particles >14µm		ASTM D7647	>640	**223**	14	10
Particles >21µm		ASTM D7647	>160	**35**	3	3
Particles >38µm		ASTM D7647	>40	**1**	0	1
Particles >71µm		ASTM D7647	>10	**0**	0	1
Oil Cleanliness		ISO 4406 (c)	>20/18/16	▲ **23/20/15**	▲ 23/18/11	▲ 23/19/10

Recommendation
We recommend you service the filters on this component if applicable. Resample at the next service interval to monitor.

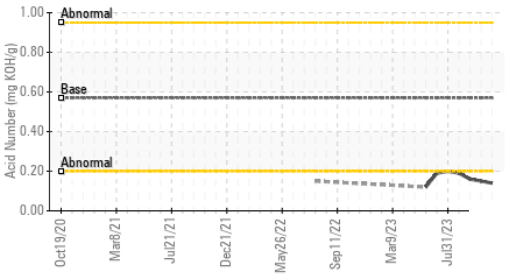
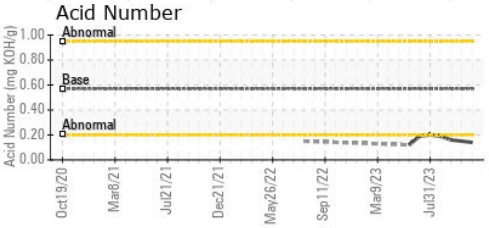
Fluid Condition
The AN level is acceptable for this fluid. The condition of the oil is suitable for further service.

FLUID DEGRADATION		method	limit/base	current	history1	history2
Acid Number (AN)	mg KOH/g	ASTM D8045	0.57	**0.14**	0.15	0.16

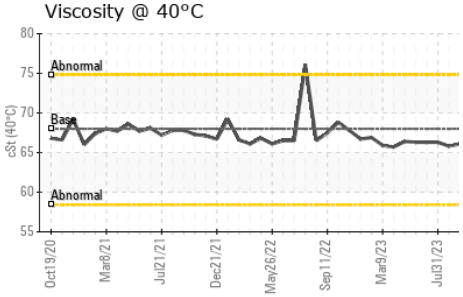
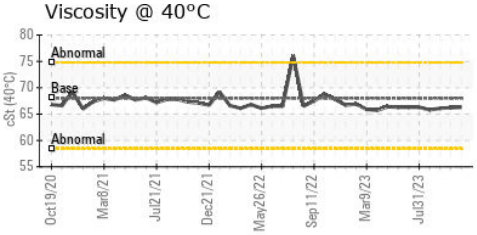
Viscosity @ 40°C

FLUID PROPERTIES		method	limit/base	current	history1	history2
Visc @ 40°C	cSt	ASTM D445	68	**66.3**	66.2	66.1

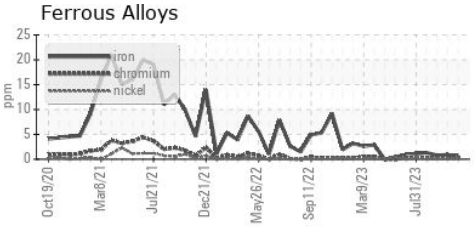
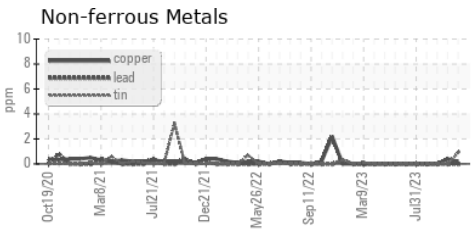
Ferrous Alloys

Wear
All component wear rates are normal.
