PROBLEM SUMMARY

Area
TALLASSEE
Machine Id
927049-162509
Component
Diesel Engine
Fluid
MOBIL DELVAC 1300 SUPER15W40 (--- LTR)

OIL ANALYSIS REPORT

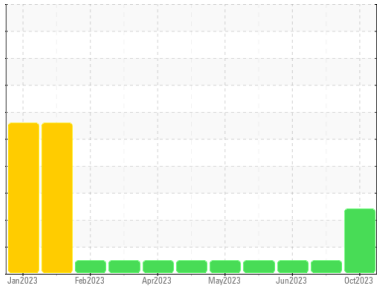
Sample Rating Trend

DIRT

Sample Status				ABNORMAL	NORMAL	NORMAL
Aluminum	ppm	ASTM D5185m	>20	▲ 17	0	7
Silicon	ppm	ASTM D5185m	>25	▲ 31	6	12

We advise that you check the air filter, air induction system, and any areas where dirt may enter the component. Oil and filter change at the time of sampling has been noted. Resample at the next service interval to monitor.

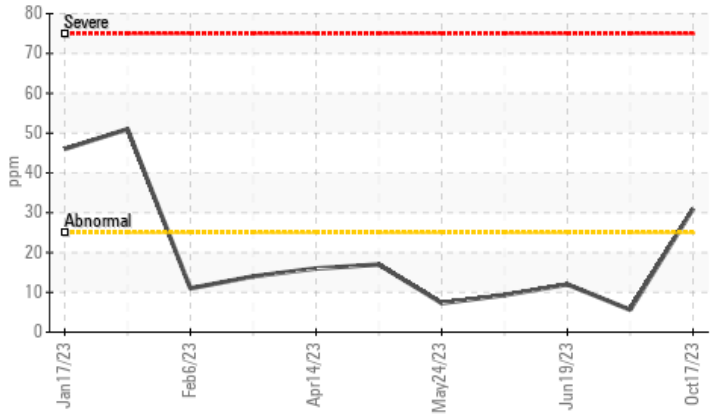
▲ Silicon (ppm)

Contamination
Elemental levels of silicon (Si) and aluminum (Al) indicate alumina-silicate (coarse dirt) ingress.

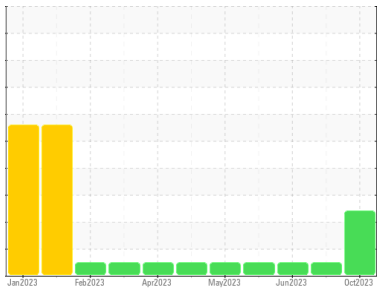
Sample Rating Trend

DIRT

Recommendation
We advise that you check the air filter, air induction system, and any areas where dirt may enter the component. Oil and filter change at the time of sampling has been noted. Resample at the next service interval to monitor.

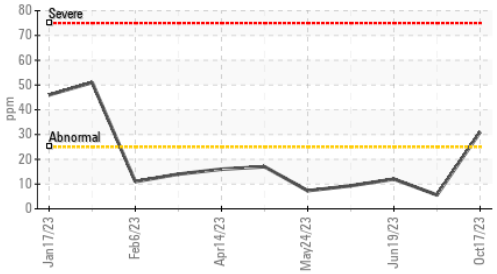
Silicon (ppm)

CONTAMINANTS		method	limit/base	current	history1	history2
Silicon	ppm	ASTM D5185m	>25	▲ **31**	6	12
Sodium	ppm	ASTM D5185m		**29**	1	10
Potassium	ppm	ASTM D5185m	>20	**7**	2	2

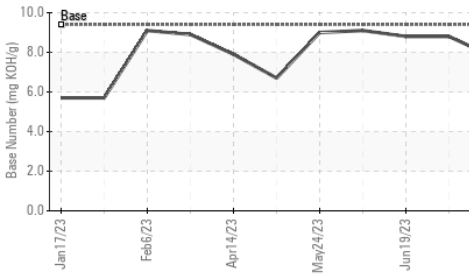
Base Number

Fluid Condition
The BN result indicates that there is suitable alkalinity remaining in the oil. The condition of the oil is acceptable for the time in service.

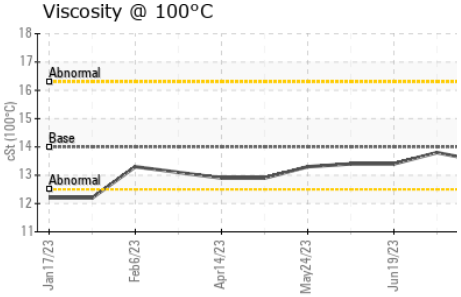
Viscosity @ 100°C

FLUID PROPERTIES		method	limit/base	current	history1	history2
Visc @ 100°C	cSt	ASTM D445	14	**13.5**	13.8	13.4
