Customer Id: GFL035
Sample No.: GFL0085166
Lab Number: 06000239
Test Package: FLEET

OIL ANALYSIS REPORT

Area
GFL035
Machine Id
934043
Component
Diesel Engine
Fluid
NOT GIVEN (40 QTS)

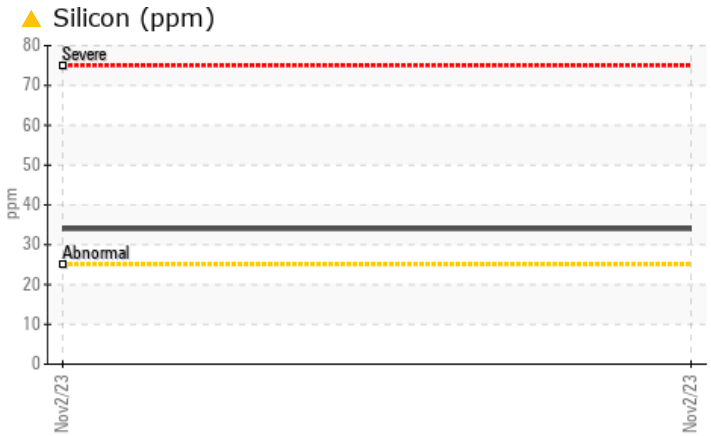
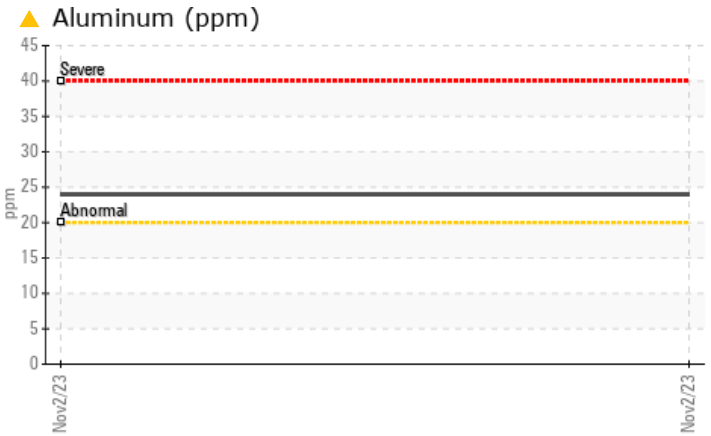
Sample Rating Trend

DIRT

Elemental levels of silicon (Si) and aluminum (Al) indicate alumina-silicate (coarse dirt) ingress. Elevated aluminum (Al) and/or lead (Pb) and potassium (K) levels in your metals analysis are likely a result of solder flux release into the lubricant and is common on new equipment/components.

We advise that you check the air filter, air induction system, and any areas where dirt may enter the component. Oil and filter change at the time of sampling has been noted. Resample at the next service interval to monitor. Please specify the brand, type, and viscosity of the oil on your next sample.

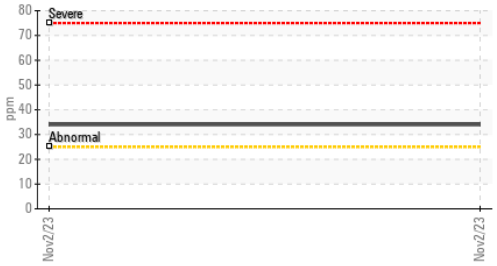
Silicon (ppm)

CONTAMINANTS		method	limit/base	current	history1	history2
Silicon	ppm	ASTM D5185m	>25	▲ **34**	---	---
Sodium	ppm	ASTM D5185m		**2**	---	---
Potassium	ppm	ASTM D5185m	>20	**79**	---	---

We advise that you check the air filter, air induction system, and any areas where dirt may enter the component. Oil and filter change at the time of sampling has been noted. Resample at the next service interval to monitor. Please specify the brand, type, and viscosity of the oil on your next sample.

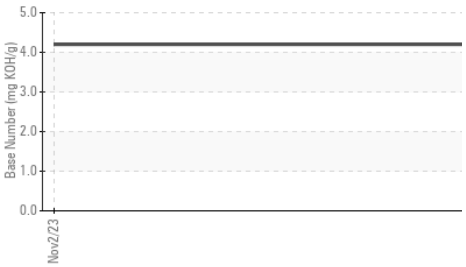
Base Number

The BN result indicates that there is suitable alkalinity remaining in the oil. The condition of the oil is acceptable for the time in service.

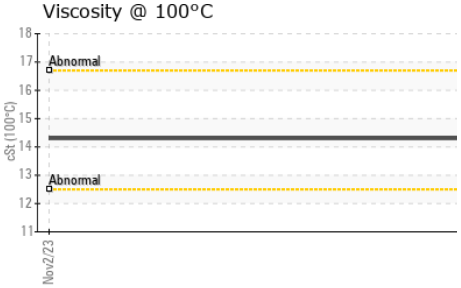
Viscosity @ 100°C

FLUID PROPERTIES		method	limit/base	current	history1	history2
Visc @ 100°C	cSt	ASTM D445		**14.3**	---	---

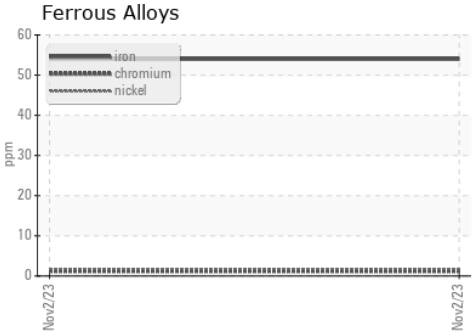
Ferrous Alloys

All component wear rates are normal.
