OIL DIAGNOSTICS

Area
PROCESS CHEESE [98620100]
Machine Id
AUGER CART 2 WEST
Component
Gearbox
Fluid
GEAR OIL ISO 220 (--- GAL)

OIL ANALYSIS REPORT

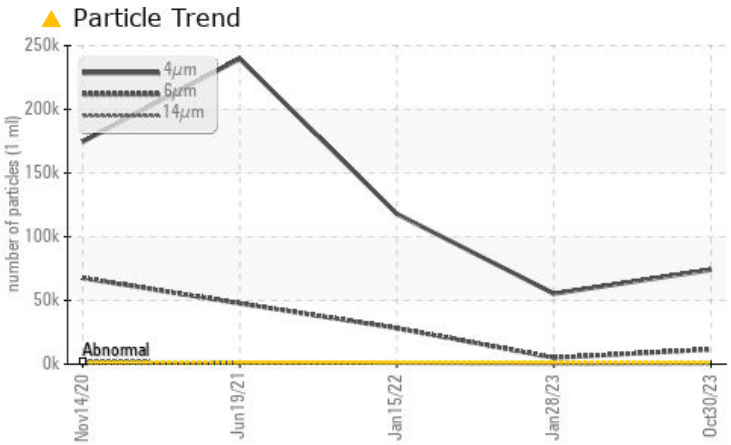
COMPONENT CONDITION SUMMARY

Sample Status				ABNORMAL	ABNORMAL	ABNORMAL
Particles >4µm		ASTM D7647	>1300	▲ **74014**	▲ 55310	▲ 117948
Particles >6µm		ASTM D7647	>320	▲ **11558**	▲ 4991	▲ 28198
Particles >14µm		ASTM D7647	>80	▲ **251**	54	▲ 533
Particles >21µm		ASTM D7647	>20	▲ **34**	6	▲ 34
Oil Cleanliness		ISO 4406 (c)	>17/15/13	▲ **23/21/15**	▲ 23/19/13	▲ 24/22/16

The oil change at the time of sampling has been noted. We recommend you service the filters on this component if applicable. Resample at the next service interval to monitor.
