OIL DIAGNOSTICS

Area
NAT CUTS [98435209]
Machine Id
LINE 1 CUBER
Component
Hydraulic System
Fluid
AW HYDRAULIC OIL ISO 46 (--- GAL)

Customer Id: KRASPRMO
Sample No.: PCA0101640
Lab Number: 06001559
Test Package: IND 2

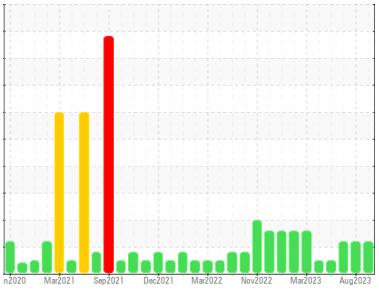
Sample Rating Trend

Sample Status				ABNORMAL	ABNORMAL	ABNORMAL
Particles >4µm		ASTM D7647	>1300	▲ **11308**	▲ 7140	▲ 10068
Particles >6µm		ASTM D7647	>320	▲ **2591**	▲ 988	▲ 1279
Oil Cleanliness		ISO 4406 (c)	>17/15/13	▲ **21/19/13**	▲ 20/17/13	▲ 21/17/12

The filter change at the time of sampling has been noted. Resample at the next service interval to monitor.

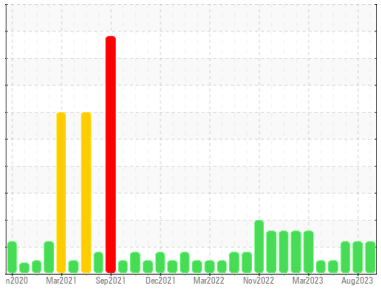
Sample Rating Trend

Contamination
There is a high amount of silt (particulates < 14 microns in size) present in the oil.

Recommendation
The filter change at the time of sampling has been noted. Resample at the next service interval to monitor.

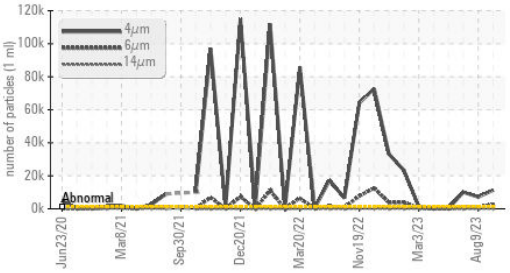
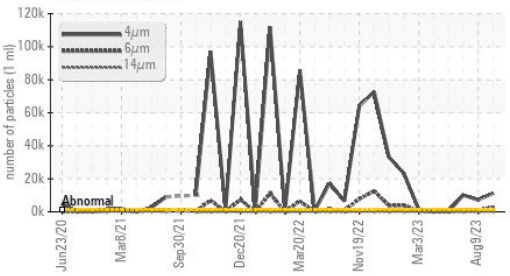
Particle Trend

FLUID CLEANLINESS		method	limit/base	current	history1	history2
Particles >4µm		ASTM D7647	>1300	▲ **11308**	▲ 7140	▲ 10068
Particles >6µm		ASTM D7647	>320	▲ **2591**	▲ 988	▲ 1279
Particles >14µm		ASTM D7647	>80	**75**	47	25
Particles >21µm		ASTM D7647	>20	**8**	13	6
Particles >38µm		ASTM D7647	>4	**0**	0	1
Particles >71µm		ASTM D7647	>3	**0**	0	0
Oil Cleanliness		ISO 4406 (c)	>17/15/13	▲ **21/19/13**	▲ 20/17/13	▲ 21/17/12

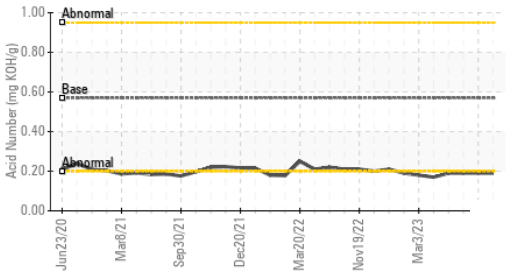
Acid Number

Fluid Condition
The AN level is acceptable for this fluid. The condition of the oil is suitable for further service.

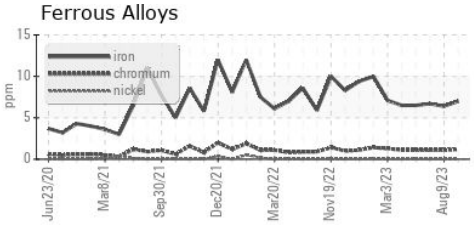
Ferrous Alloys

Wear
All component wear rates are normal.
