OIL DIAGNOSTICS

Area
**[98604896]**
Machine Id
## KR-GR-003115 - WEST DUMPER (S/N MIX E - 11513079)
Component
**Hydraulic System**
Fluid
**AW HYDRAULIC OIL ISO 68 (--- GAL)**

# OIL ANALYSIS REPORT

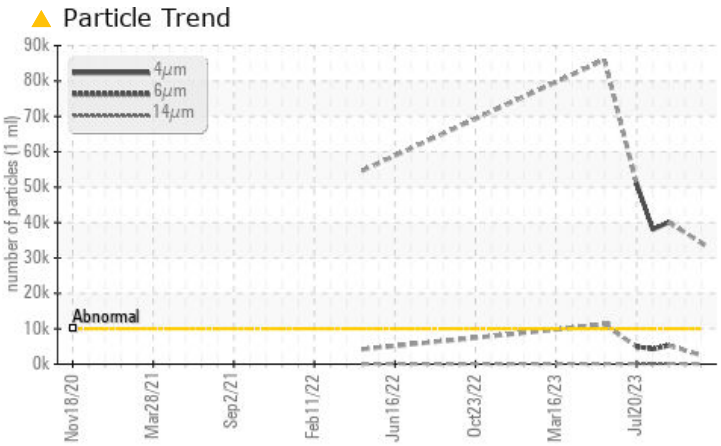
## COMPONENT CONDITION SUMMARY

| Sample Status | | | | ABNORMAL | NORMAL | ABNORMAL |
|---|---|---|---|---|---|---|
| Oil Cleanliness | | ISO 4406 (c) | >20/18/16 | ▲ **22/19/12** | --- | ▲ 23/20/15 |

We recommend you service the filters on this component. Resample at the next service interval to monitor.

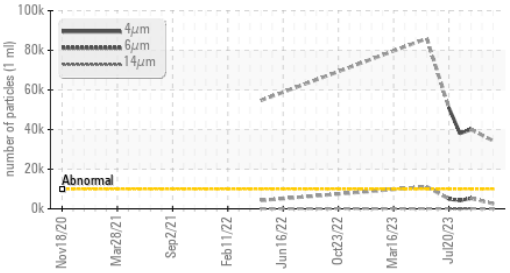
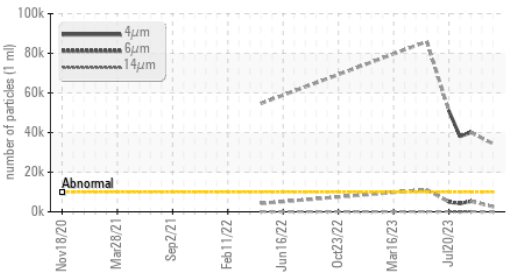
Particle Trend

**Contamination**
There is a high amount of silt (particulates < 14 microns in size) present in the oil.

| FLUID CLEANLINESS | | method | limit/base | current | history1 | history2 |
|---|---|---|---|---|---|---|
| Particles >4µm | | ASTM D7647 | >10000 | ▲ **34342** | --- | ▲ 40067 |
| Particles >6µm | | ASTM D7647 | >2500 | ▲ **2575** | --- | ▲ 5292 |
| Oil Cleanliness | | ISO 4406 (c) | >20/18/16 | ▲ **22/19/12** | --- | ▲ 23/20/15 |

**Recommendation**
We recommend you service the filters on this component. Resample at the next service interval to monitor.

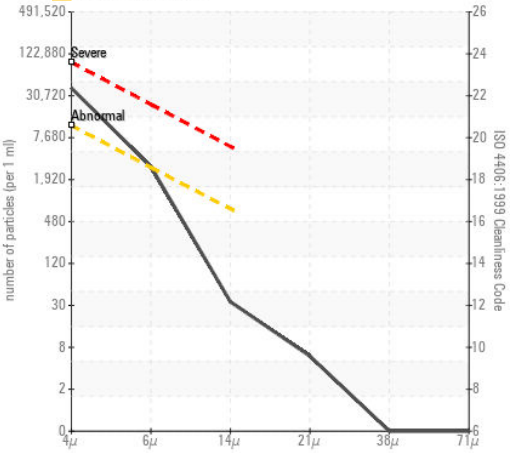
Particle Count

| Sample Status | | | | ABNORMAL | NORMAL | ABNORMAL |
|---|---|---|---|---|---|---|
| Particles >4µm | | ASTM D7647 | >10000 | ▲ **34342** | --- | ▲ 40067 |
| Particles >6µm | | ASTM D7647 | >2500 | ▲ **2575** | --- | ▲ 5292 |
