OIL DIAGNOSTICS

Area
FLEET
Machine Id
2126948 (S/N N603211)
Component
Transmission
Fluid
NOT GIVEN (--- GAL)

OIL ANALYSIS REPORT

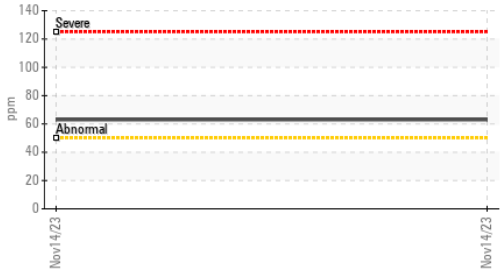
Silicon (ppm)

Elemental level of silicon (Si) above normal indicating ingress of seal material.

CONTAMINANTS		method	limit/base	current	history1	history2
Silicon	ppm	ASTM D5185m	>50	▲ **63**	---	---
Sodium	ppm	ASTM D5185m		**2**	---	---
Potassium	ppm	ASTM D5185m	>20	**0**	---	---

No corrective action is recommended at this time. Resample at the next service interval to monitor. Please specify the brand, type, and viscosity of the oil on your next sample.

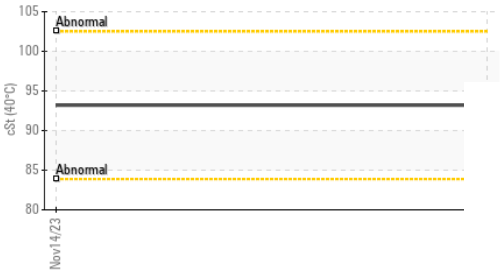
Viscosity @ 40°C

FLUID PROPERTIES		method	limit/base	current	history1	history2
Visc @ 40°C	cSt	ASTM D445		**93.2**	---	---
