OIL DIAGNOSTICS

Area
FLEET
Machine Id
Volvo 2126935
Component
1 Differential
Fluid
GEAR OIL SAE 75W90 (--- GAL)

OIL ANALYSIS REPORT

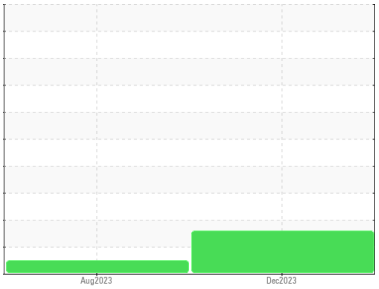
Sample Rating Trend

DIRT

Sample Status				**ABNORMAL**	NORMAL	---
Silicon	ppm	ASTM D5185m	>75	▲ **117**	59	---

No corrective action is recommended at this time.
Resample at the next service interval to monitor.

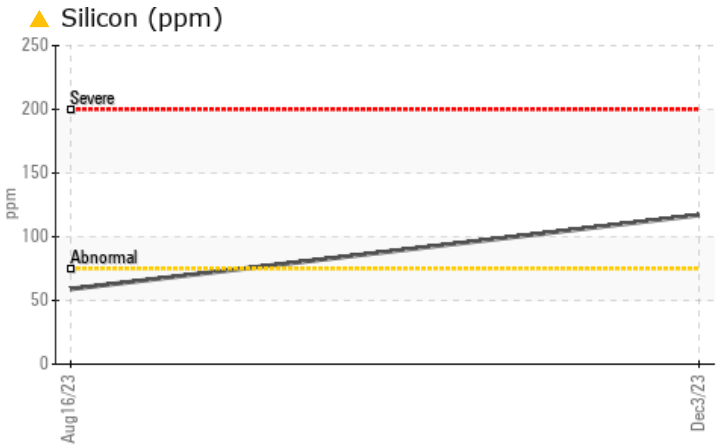
COMPONENT CONDITION SUMMARY

Contamination
Elemental level of silicon (Si) above normal indicating ingress of dirt/seal material.

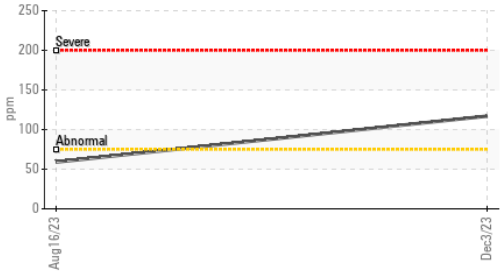
Silicon (ppm)

CONTAMINANTS		method	limit/base	current	history1	history2
Silicon	ppm	ASTM D5185m	>75	▲ **117**	59	---
Sodium	ppm	ASTM D5185m		**9**	6	---
Potassium	ppm	ASTM D5185m	>20	**2**	2	---

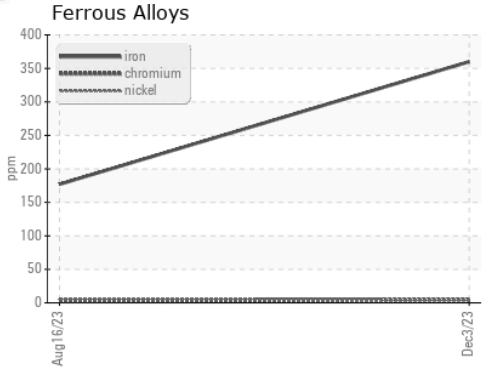
Ferrous Alloys

Wear
All component wear rates are normal.

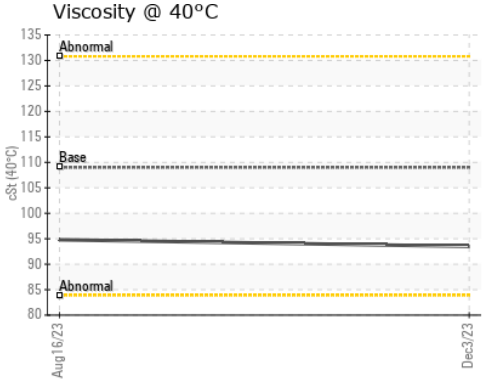
Viscosity @ 40°C

Fluid Condition
The condition of the oil is acceptable for the time in service.
