OIL ANALYSIS REPORT

Machine Id
427182
Component
Transmission (Auto)
Fluid
NOT GIVEN (--- GAL)

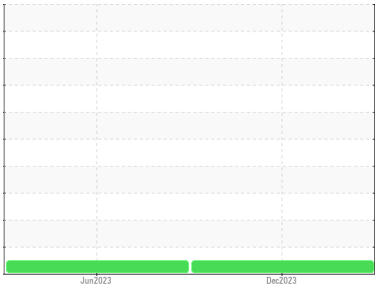
Sample Rating Trend

NORMAL

Wear
All component wear rates are normal.

Contamination
There is no indication of any contamination in the fluid.

Fluid Condition
The condition of the fluid is acceptable for the time in service.

Recommendation
Resample at the next service interval to monitor. (Customer Sample Comment: Transmission)
