OIL ANALYSIS REPORT

Machine Id
420026-402479
Component
Diesel Engine
Fluid
PETRO CANADA DURON SHP 15W40 (--- GAL)

Laboratory : WearCheck USA - 501 Madison Ave., Cary, NC 27513
Sample No. : GFL0100546
Lab Number : 06051734
Unique Number : 10817683
Test Package : FLEET

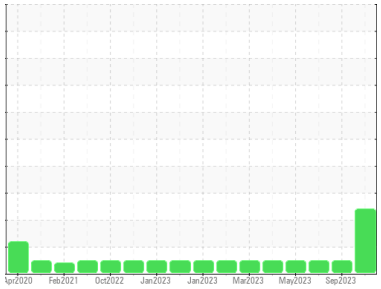
Sample Rating Trend

DIRT

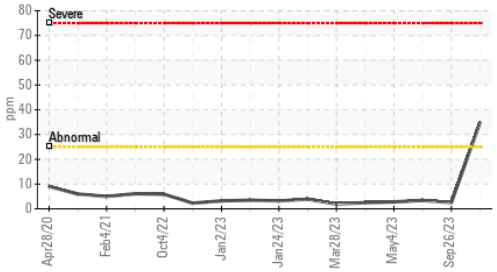
Silicon (ppm)

Contamination
Elemental level of silicon (Si) above normal indicating ingress of seal material.

CONTAMINANTS		method	limit/base	current	history1	history2
Silicon	ppm	ASTM D5185m	>25	▲ **35**	2	3
Sodium	ppm	ASTM D5185m		**4**	5	4
Potassium	ppm	ASTM D5185m	>20	**7**	4	7

Recommendation
Oil and filter change at the time of sampling has been noted. Resample at the next service interval to monitor.

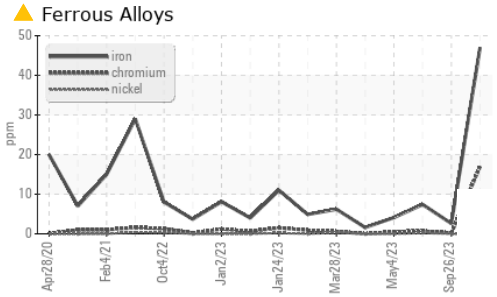
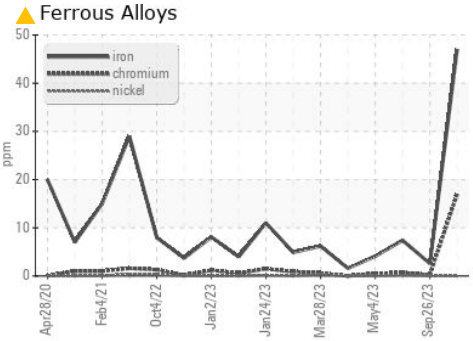
Ferrous Alloys

Wear
The chromium level is marginal.

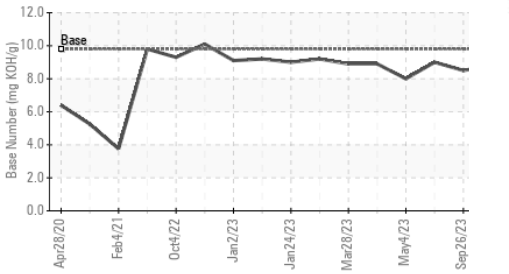
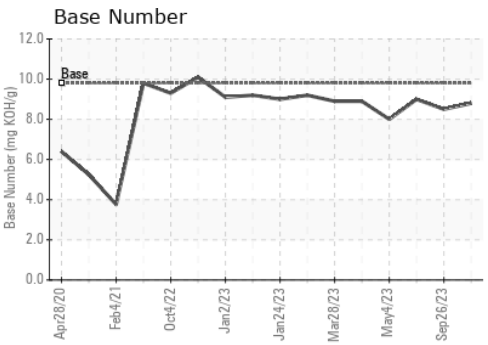
Base Number

Fluid Condition
The BN result indicates that there is suitable alkalinity remaining in the oil. The condition of the oil is acceptable for the time in service.
