OIL ANALYSIS REPORT

Area
(P837499)
Machine Id
2623
Component
Diesel Engine
Fluid
PETRO CANADA DURON SHP 15W40 (8 GAL)

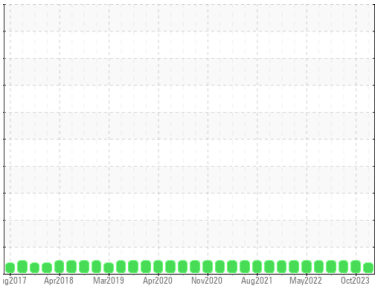
Sample Rating Trend

The oil viscosity is lower than normal. The BN result indicates that there is suitable alkalinity remaining in the oil.

SAMPLE INFORMATION		method	limit/base	current	history1	history2
Sample Number		Client Info		**GFL0096914**	GFL0050891	GFL0069780
Sample Date		Client Info		**08 Feb 2024**	03 Oct 2023	24 Aug 2023
Machine Age	hrs	Client Info		**14107**	13542	13121
Oil Age	hrs	Client Info		**565**	13121	263
Oil Changed		Client Info		**Not Changd**	Changed	Changed
Sample Status				**MARGINAL**	NORMAL	NORMAL

No corrective action is recommended at this time. Resample at the next service interval to monitor.

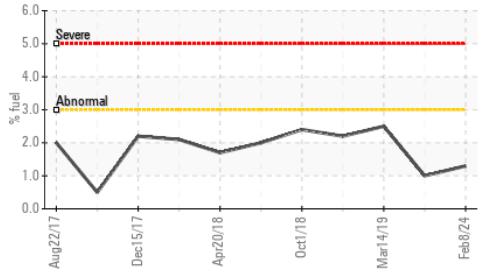
Fuel Dilution

Fuel content negligible. There is no indication of any contamination in the oil.

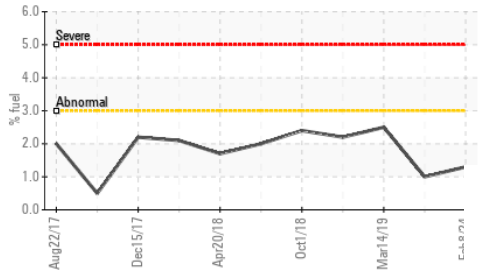
Fuel Dilution

CONTAMINANTS		method	limit/base	current	history1	history2
Silicon	ppm	ASTM D5185m	>25	**6**	4	5
Sodium	ppm	ASTM D5185m		**0**	2	2
Potassium	ppm	ASTM D5185m	>20	**2**	1	2
Fuel	%	ASTM D3524	>3.0	**1.3**	<1.0	<1.0

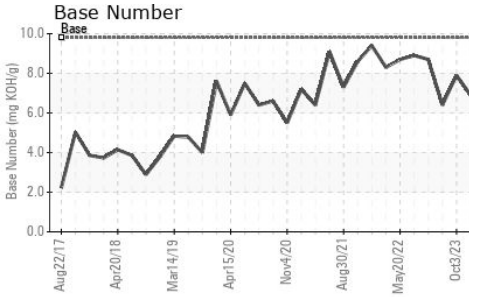
FLUID DEGRADATION		method	limit/base	current	history1	history2
Oxidation	Abs/.1mm	*ASTM D7414	>25	**14.6**	13.1	15.3
Base Number (BN)	mg KOH/g	ASTM D2896	9.8	**6.9**	7.9	6.4

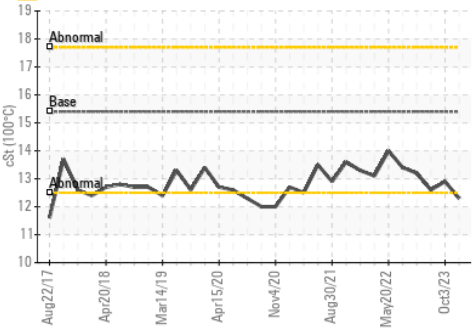
▲ Viscosity @ 100°C

FLUID PROPERTIES		method	limit/base	current	history1	history2
Visc @ 100°C	cSt	ASTM D445	15.4	▲ **12.3**	12.9	12.6
