OIL ANALYSIS REPORT

Area
(29KK9A)
Machine Id
721020-361648
Component
Diesel Engine
Fluid
PETRO CANADA DURON SHP 15W40 (--- GAL)

Laboratory : WearCheck USA - 501 Madison Ave., Cary, NC 27513
Sample No. : GFL0114087
Lab Number : 06127555
Unique Number : 10941706
Test Package : FLEET (Additional Tests: PercentFuel)

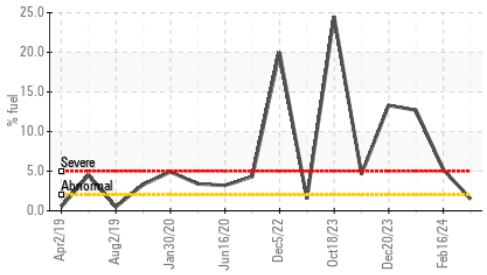
Fuel Dilution

Contamination
Light fuel dilution occurring. No other contaminants were detected in the oil.

CONTAMINANTS		method	limit/base	current	history1	history2
Silicon	ppm	ASTM D5185m	>25	**5**	4	10
Sodium	ppm	ASTM D5185m		**45**	31	▲ 90
Potassium	ppm	ASTM D5185m	>20	**37**	32	▲ 93
Fuel	%	ASTM D3524	>2.0	**1.5**	▲ 5.2	▲ 12.7

Recommendation
No corrective action is recommended at this time. Resample at the next service interval to monitor.

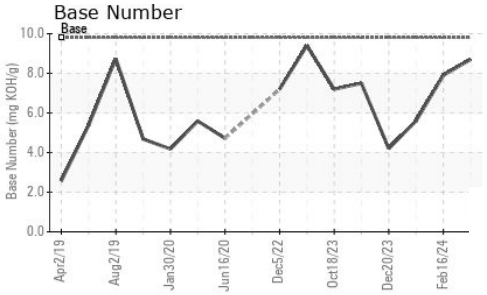
Base Number

Fluid Condition
The BN result indicates that there is suitable alkalinity remaining in the oil. The condition of the oil is suitable for further service.

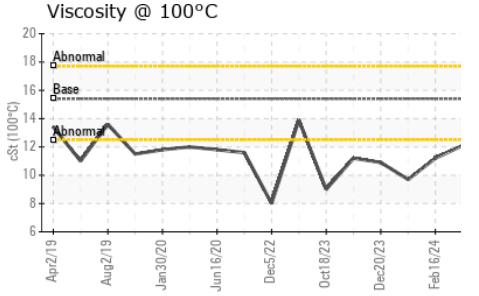
Viscosity @ 100°C

FLUID PROPERTIES		method	limit/base	current	history1	history2
Visc @ 100°C	cSt	ASTM D445	15.4	**12.1**	▲ 11.2	▲ 9.7

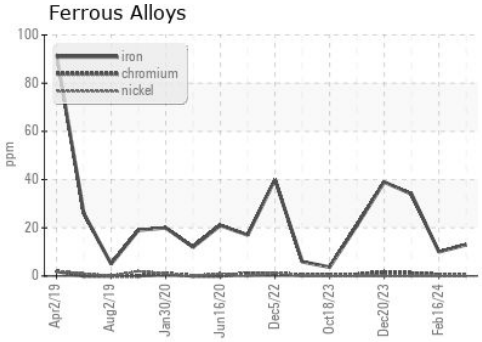
Ferrous Alloys

Wear
All component wear rates are normal.
