# PROBLEM SUMMARY

Machine Id
**723031-303001**
Component
**Diesel Engine**
Fluid
**PETRO CANADA DURON SHP 15W40 (--- GAL)**

# OIL ANALYSIS REPORT

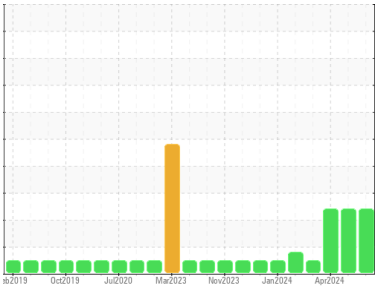
**Sample Rating Trend**

**FUEL**

| Sample Status | | | | **SEVERE** | SEVERE | SEVERE |

We advise that you check the fuel injection system. Oil and filter change at the time of sampling has been noted. We recommend an early resample to monitor this condition.

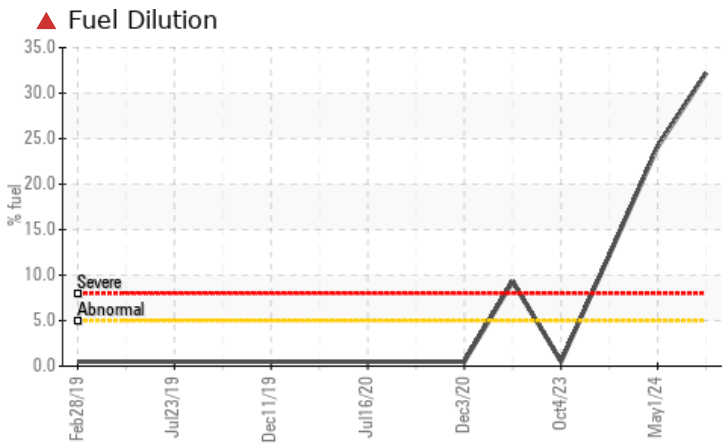
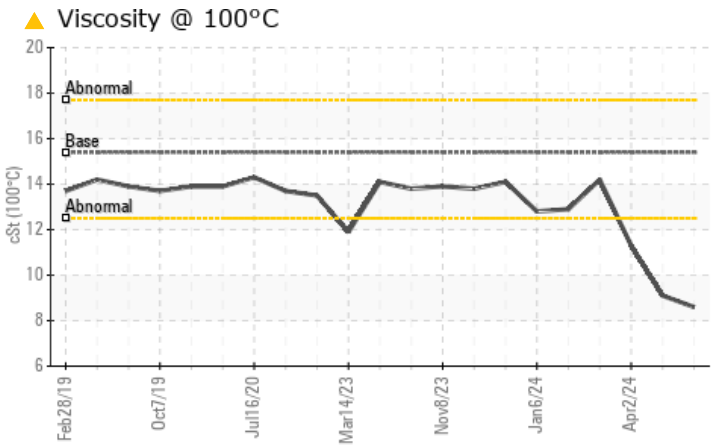
## COMPONENT CONDITION SUMMARY

| Sample Status | | | | **SEVERE** | SEVERE | SEVERE |
|---|---|---|---|---|---|---|
| Fuel | % | ASTM D3524 | >5 | ▲ **32.2** | ▲ 24.1 | ▲ 12.2 |
| Visc @ 100°C | cSt | ASTM D445 | 15.4 | ▲ **8.6** | ▲ 9.1 | ▲ 11.3 |

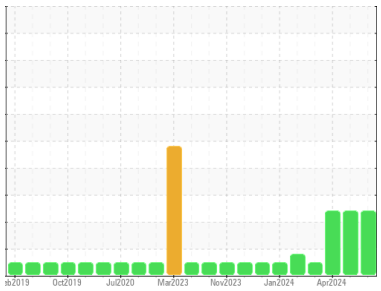
Sample Rating Trend

**FUEL**

**Contamination**
There is a high amount of fuel present in the oil.

**Fluid Condition**
Fuel is present in the oil and is lowering the viscosity. The oil is no longer serviceable due to the presence of contaminants.

**Recommendation**
We advise that you check the fuel injection system. Oil and filter change at the time of sampling has been noted. We recommend an early resample to monitor this condition.

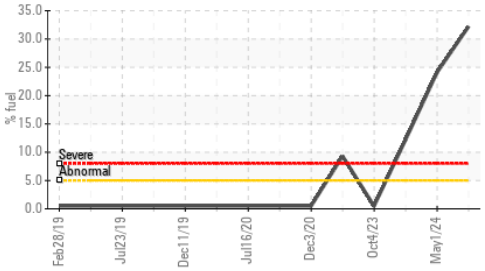
Fuel Dilution

| CONTAMINANTS | | method | limit/base | current | history1 | history2 |
|---|---|---|---|---|---|---|
| Fuel | % | ASTM D3524 | >5 | ▲ **32.2** | ▲ 24.1 | ▲ 12.2 |

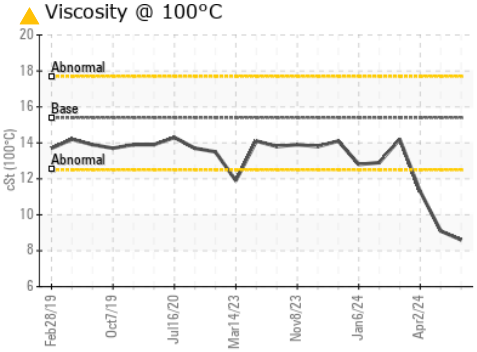
Viscosity @ 100°C

| FLUID PROPERTIES | | method | limit/base | current | history1 | history2 |
|---|---|---|---|---|---|---|
| Visc @ 100°C | cSt | ASTM D445 | 15.4 | ▲ **8.6** | ▲ 9.1 | ▲ 11.3 |
