OIL DIAGNOSTICS

Area
STUFF ROOM E [99031153]
Machine Id
KR-GR-003484 - AGITATOR (S/N STUFF E - 11513146)
Component
Gearbox
Fluid
SCHAEFFER 293A SUPREME GEAR LUBE NO TACK 220 (--- GAL)

Customer Id: KRAKIR
Sample No.: PCA0128829
Lab Number: 06228497
Test Package: IND 2

OIL ANALYSIS REPORT

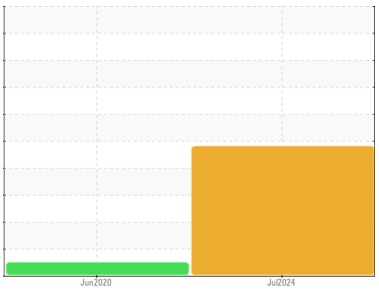
Sample Rating Trend

WATER

Sample Status				**SEVERE**	NORMAL	---
Free Water	scalar	*Visual		▲ **>10%**	NEG	---

We advise that you check for the source of water entry. We advise that you follow the water drain-off procedure for this component. We recommend an early resample to monitor this condition. (Customer Sample Comment: 99031153)

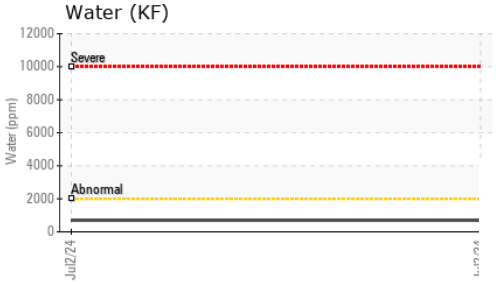
Water (KF)

▲ Contamination
Excessive free water present. The amount and size of particulates present in the system are acceptable.

CONTAMINANTS		method	limit/base	current	history1	history2
Silicon	ppm	ASTM D5185m	>50	**3**	4	---
Sodium	ppm	ASTM D5185m		**3**	0	---
Potassium	ppm	ASTM D5185m	>20	**4**	0	---
Water	%	ASTM D6304	>0.2	**0.070**	---	---
ppm Water	ppm	ASTM D6304	>2000	**700**	---	---

▲ Recommendation
We advise that you check for the source of water entry. We advise that you follow the water drain-off procedure for this component. We recommend an early resample to monitor this condition. (Customer Sample Comment: 99031153)

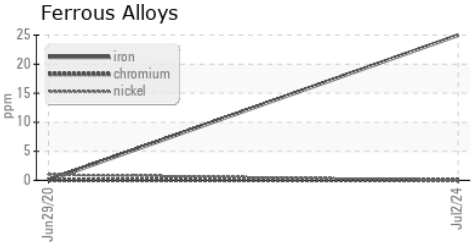
Ferrous Alloys

Wear
All component wear rates are normal.

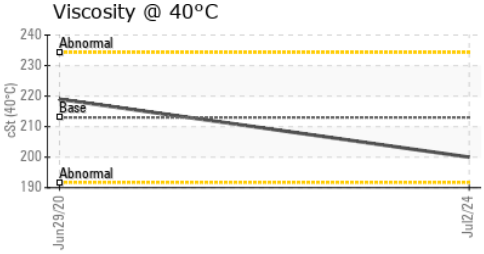
Viscosity @ 40°C

FLUID PROPERTIES		method	limit/base	current	history1	history2
Visc @ 40°C	cSt	ASTM D445	213	**200**	219	---

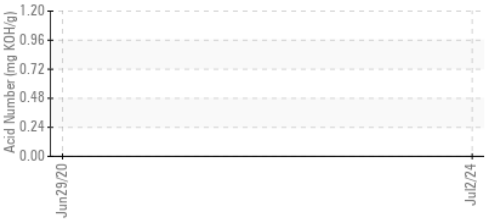
Acid Number

Fluid Condition
The AN level is acceptable for this fluid.
