OIL ANALYSIS REPORT

Machine Id
LSGS SLUICE GATE 2
Component
Pump Hydraulic System
Fluid
BIOFLO AWS 2 (80 GAL)

Laboratory : WearCheck - C8-1175 Appleby Line, Burlington, ON L7L 5H9
Sample No. : WC0373463
Lab Number : 02373505
Unique Number : 5096953
Test Package : IND 2

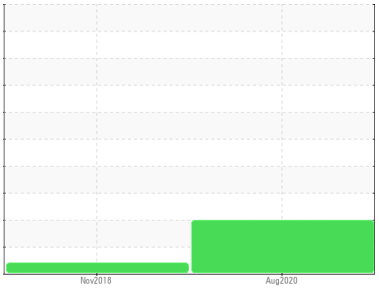
Sample Rating Trend

DEGRADATION

Wear
Nickel ppm levels are abnormal.

Fluid Condition
The AN level is above the recommended limit. The oil is no longer serviceable.

Recommendation
We recommend that you drain the oil from the component if this has not already been done. We recommend an early resample to monitor this condition.

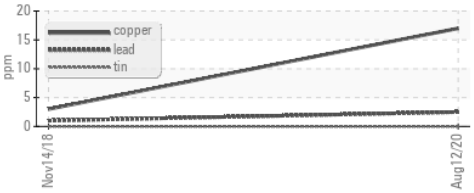
Non-ferrous Metals

WEAR METALS		method	limit/base	current	history1	history2
Iron	ppm	ASTM D5185(m)	>20	**2**	<1	---
Chromium	ppm	ASTM D5185(m)	>20	**<1**	0	---
Nickel	ppm	ASTM D5185(m)	>20	▲ **22**	<1	---
Titanium	ppm	ASTM D5185(m)		**0**	0	---
Silver	ppm	ASTM D5185(m)		**0**	0	---
Aluminum	ppm	ASTM D5185(m)	>20	**<1**	<1	---
Lead	ppm	ASTM D5185(m)	>20	**2**	1	---
Copper	ppm	ASTM D5185(m)	>20	**17**	3	---
Tin	ppm	ASTM D5185(m)	>20	**0**	0	---
Antimony	ppm	ASTM D5185(m)		**<1**	0	---
Vanadium	ppm	ASTM D5185(m)		**0**	0	---
Beryllium	ppm	ASTM D5185(m)		**0**	0	---
Cadmium	ppm	ASTM D5185(m)		**0**	0	---

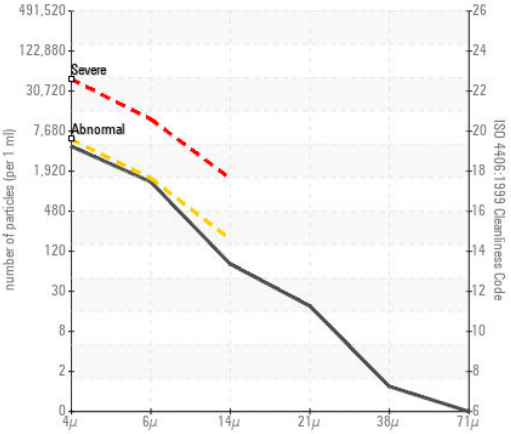
Particle Count

Contamination
The system cleanliness is acceptable for your target ISO 4406 cleanliness code. The system and fluid cleanliness is acceptable.

FLUID CLEANLINESS		method	limit/base	current	history1	history2
Particles >4µm		ASTM D7647	>5000	**3947**	▲ 7808	---
Particles >6µm		ASTM D7647	>1300	**1156**	1244	---
Particles >14µm		ASTM D7647	>160	**68**	63	---
Particles >21µm		ASTM D7647	>40	**16**	19	---
Particles >38µm		ASTM D7647	>10	**1**	0	---
Particles >71µm		ASTM D7647	>3	**0**	0	---
Oil Cleanliness		ISO 4406 (c)	>19/17/14	**19/17/13**	▲ 20/17/13	---

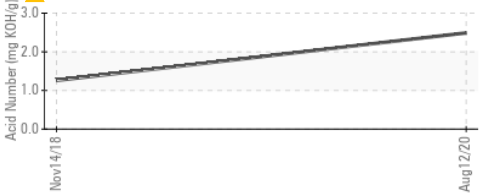
FLUID DEGRADATION		method	limit/base	current	history1	history2
Acid Number (AN)	mg KOH/g	ASTM D974*		▲ **2.49**	1.26	---
