Machine Id
PHR-G2-TUBR
Component
Bearing
Fluid
MOBIL DTE OIL HVY MEDIUM (--- GAL)

Customer Id: NEWSTJ
Sample No.: WC0327913
Lab Number: 02404910
Test Package: IND 2

OIL ANALYSIS REPORT

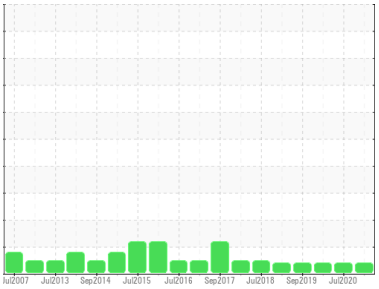
Sample Rating Trend

ABNORMAL	ABNORMAL	ATTENTION
Sample Status				**ABNORMAL**	ABNORMAL	ATTENTION
Particles >4µm		ASTM D7647	>10000	**35643**	36034	15481
Oil Cleanliness		ISO 4406 (c)	>20/18/14	**22/18/14**	22/18/11	21/18/14

Contamination
Particles >4µm are abnormally high.

We recommend you service the filters on this component. We recommend an early resample to monitor this condition. NOTE: Please provide information regarding reservoir capacity, filter type and micron rating with next sample.

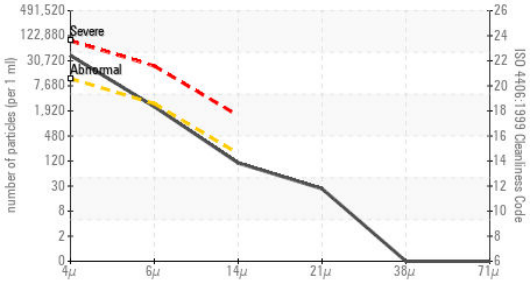
Particle Count

FLUID CLEANLINESS		method	limit/base	current	history1	history2
Particles >4µm		ASTM D7647	>10000	▲ **35643**	▲ 36034	▲ 15481
Particles >6µm		ASTM D7647	>2500	**2127**	1394	1606
Particles >14µm		ASTM D7647	>160	**95**	19	101
Particles >21µm		ASTM D7647	>40	**23**	3	32
Particles >38µm		ASTM D7647	>10	**0**	0	2
Particles >71µm		ASTM D7647	>3	**0**	0	0
Oil Cleanliness		ISO 4406 (c)	>20/18/14	▲ **22/18/14**	▲ 22/18/11	▲ 21/18/14

Recommendation
We recommend you service the filters on this component. We recommend an early resample to monitor this condition. NOTE: Please provide information regarding reservoir capacity, filter type and micron rating with next sample.

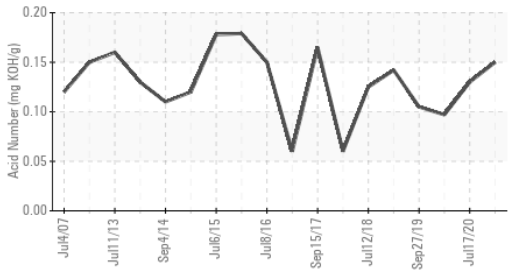
Fluid Condition
The AN level is acceptable for this fluid. The condition of the oil is suitable for further service.

FLUID DEGRADATION		method	limit/base	current	history1	history2
Acid Number (AN)	mg KOH/g	ASTM D974*		**0.15**	0.13	0.097
