Machine Id
WES GG LUBE SYSTEM
Component
Lube System
Fluid
EASTMAN TURBO OIL 2380 (200 LTR)

Customer Id: NEWSTJ
Sample No.: WC0327904
Lab Number: 02467342
Test Package: IND 2

OIL ANALYSIS REPORT

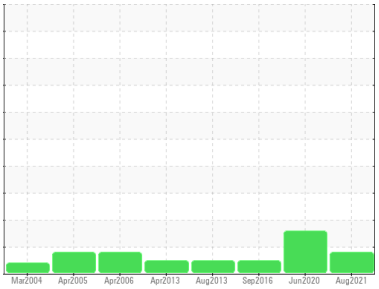
Sample Rating Trend

Sample Status				ABNORMAL	SEVERE	NORMAL
Particles >4µm		ASTM D7647	>5000	▲ **15899**	⬢ 61142	1699
Particles >6µm		ASTM D7647	>1300	▲ **2125**	▲ 8951	98
Oil Cleanliness		ISO 4406 (c)	>19/17/14	▲ **21/18/14**	⬢ 23/20/15	18/14/11

Contamination
Particles >4µm are abnormally high. Particles >6µm are notably high.

We recommend you service the filters on this component. We recommend an early resample to monitor this condition.

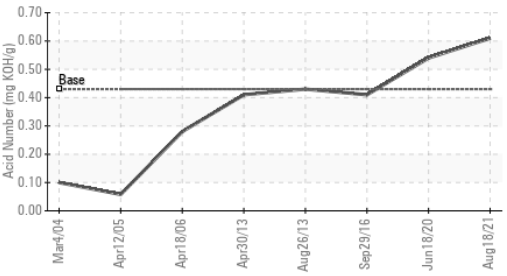
Fluid Condition
The AN level is acceptable for this fluid. The condition of the oil is suitable for further service.

FLUID DEGRADATION		method	limit/base	current	history1	history2
Acid Number (AN)	mg KOH/g	ASTM D974*	0.43	**0.61**	0.54	0.41

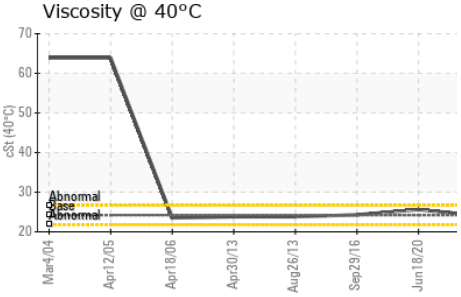
Viscosity @ 40°C

FLUID PROPERTIES		method	limit/base	current	history1	history2
Visc @ 40°C	cSt	ASTM D7279(m)	24.2	**24.1**	25.6	24.3

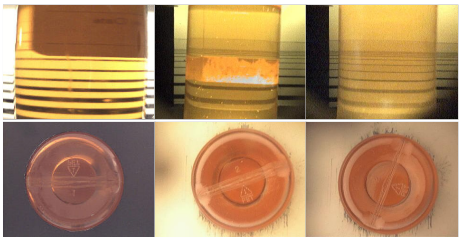
SAMPLE IMAGES	method	limit/base	current	history1	history2
Color					
Bottom

VISUAL		method	limit/base	current	history1	history2
White Metal	scalar	Visual*	NONE	**NONE**	NONE	NONE
Yellow Metal	scalar	Visual*	NONE	**NONE**	NONE	NONE
Precipitate	scalar	Visual*	NONE	**NONE**	NONE	NONE
Silt	scalar	Visual*	NONE	**NONE**	NONE	NONE
Debris	scalar	Visual*	NONE	**NONE**	NONE	NONE
Sand/Dirt	scalar	Visual*	NONE	**NONE**	NONE	NONE
Appearance	scalar	Visual*	NORML	**NORML**	NORML	NORML
Odor	scalar	Visual*	NORML	**NORML**	NORML	NORML
Emulsified Water	scalar	Visual*	>0.05	**NEG**	NEG	NEG
Free Water	scalar	Visual*		**NEG**	NEG	NEG
