Customer Id: NEWSTJ
Sample No.: WC0327870
Lab Number: 02473265
Test Package: IND 2

OIL ANALYSIS REPORT

Machine Id
VIC-G-THBR
Component
Bearing
Fluid
ESSO TERESSO ISO 68 (2 LTR)

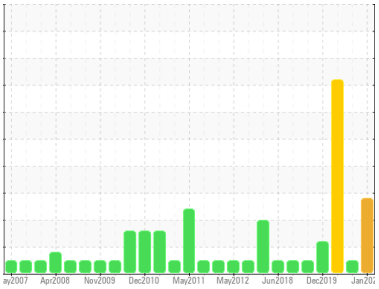
Sample Rating Trend

WATER

Sample Status				ABNORMAL	NORMAL	SEVERE
Tin	ppm	ASTM D5185(m)	>27	▲ **36**	14	⬢ 71
Antimony	ppm	ASTM D5185(m)		▲ **2**	1	▲ 6
Emulsified Water	scalar	Visual*	>2	▲ **.5%**	NEG	NEG
Free Water	scalar	Visual*		▲ **1%**	NEG	NEG

We advise that you check for the source of water entry. Check seals and/or filters for points of contaminant entry. We recommend that you drain the oil from the component if this has not already been done. We recommend an early resample to monitor this condition.

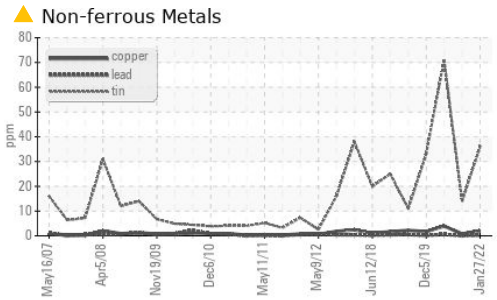
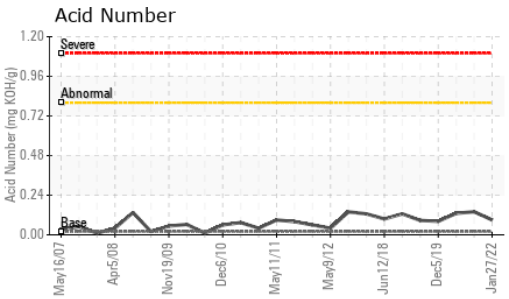
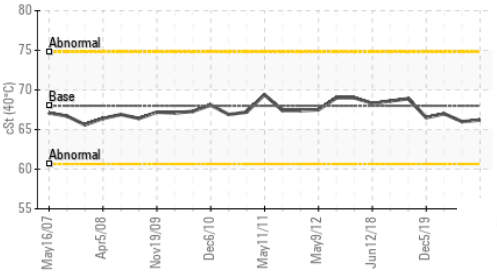
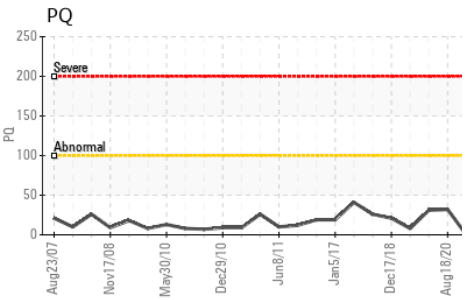
SAMPLE IMAGES	method	limit/base	current	history1	history2
Color					
Bottom

VISUAL		method	limit/base	current	history1	history2
White Metal	scalar	Visual*	NONE	**NONE**	VLITE	NONE
Yellow Metal	scalar	Visual*	NONE	**NONE**	NONE	NONE
Precipitate	scalar	Visual*	NONE	**VLITE**	NONE	NONE
Silt	scalar	Visual*	NONE	**VLITE**	VLITE	NONE
Debris	scalar	Visual*	NONE	**NONE**	NONE	NONE
Sand/Dirt	scalar	Visual*	NONE	**NONE**	NONE	NONE
Appearance	scalar	Visual*	NORML	**NORML**	HAZY	NORML
Odor	scalar	Visual*	NORML	**NORML**	NORML	NORML
Emulsified Water	scalar	Visual*	>2	▲ **.5%**	NEG	NEG
Free Water	scalar	Visual*		▲ **1%**	NEG	NEG
