Customer Id: NEWSTJ
Sample No.: WC0445374
Lab Number: 02517601
Test Package: IND 2

OIL ANALYSIS REPORT

Area
[192027]
Machine Id
MOP G GOV
Component
Pump
Fluid
ESSO TERESSO ISO 68 (91 LTR)

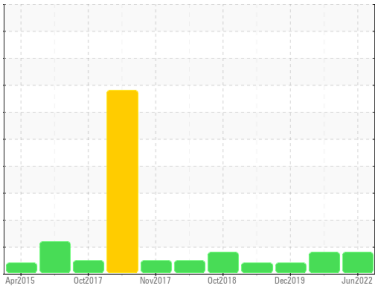
Sample Rating Trend

Sample Status				**ABNORMAL**	ABNORMAL	ATTENTION
Particles >4µm		ASTM D7647	>5000	▲ **12080**	▲ 22727	▲ 9081
Oil Cleanliness		ISO 4406 (c)	>19/17/14	▲ **21/17/11**	▲ 22/18/12	▲ 20/17/11

We recommend you service the filters on this component. We recommend an early resample to monitor this condition.

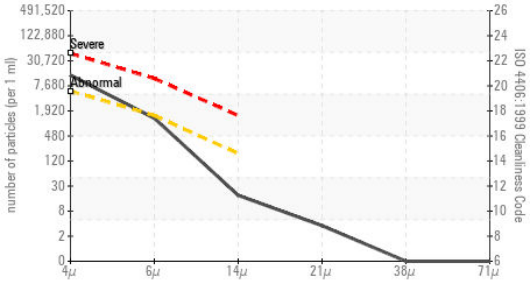
Particle Count

Contamination
Oil Cleanliness are abnormally high. Particles >4µm are abnormally high.

FLUID CLEANLINESS		method	limit/base	current	history1	history2
Particles >4µm		ASTM D7647	>5000	▲ **12080**	▲ 22727	▲ 9081
Particles >6µm		ASTM D7647	>1300	**1124**	▲ 2296	758
Particles >14µm		ASTM D7647	>160	**16**	25	14
Particles >21µm		ASTM D7647	>40	**3**	3	5
Particles >38µm		ASTM D7647	>10	**0**	0	0
Particles >71µm		ASTM D7647	>3	**0**	0	0
Oil Cleanliness		ISO 4406 (c)	>19/17/14	▲ **21/17/11**	▲ 22/18/12	▲ 20/17/11

Recommendation
We recommend you service the filters on this component. We recommend an early resample to monitor this condition.

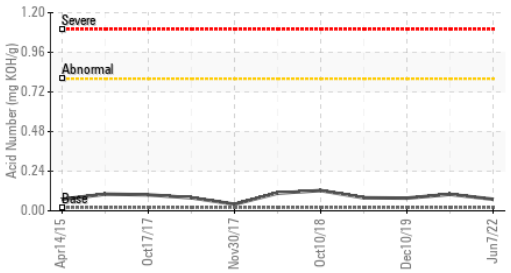
Fluid Condition
The AN level is acceptable for this fluid. The oil is still serviceable provided that the contaminant(s) can be reduced to acceptable levels.

FLUID DEGRADATION		method	limit/base	current	history1	history2
Acid Number (AN)	mg KOH/g	ASTM D974*	0.02	**0.07**	0.10	0.077

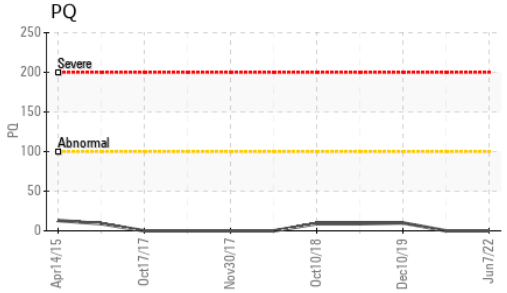
PQ

Wear
All component wear rates are normal.
