OIL ANALYSIS REPORT

Machine Id
DOOSAN DL420-5 DWGCWLBJLL1010785
Component
Hydraulic System
Fluid
DOOSAN AW 68 (--- GAL)

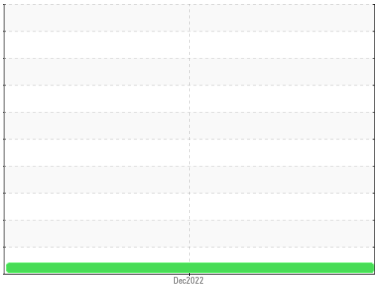
Sample Rating Trend

Fluid Condition
Viscosity of sample indicates oil is within ISO 46 range, advise investigate. The condition of the oil is acceptable for the time in service.

Recommendation
Resample at the next service interval to monitor. Please contact your representative for information regarding the proper sampling kits for your service. NOTE: We recommend using MOB 2 test kits, this testkit includes Particle Count to determine the ISO cleanliness of the fluid.

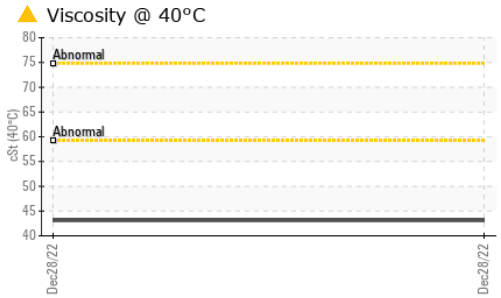
FLUID PROPERTIES		method	limit/base	current	history 1	history 2
Visc @ 40°C	cSt	ASTM D7279(m)		▲ 43.1	---	---
