PROBLEM SUMMARY

Area
#2 Slab Caster [3000630597]
Machine Id
MOULD LEVEL HYD (STL001) (S/N 1000026618)
Component
Hydraulic System
Fluid
HOUGHTON HOUGHTON SAFE 616 (--- GAL)

OIL ANALYSIS REPORT

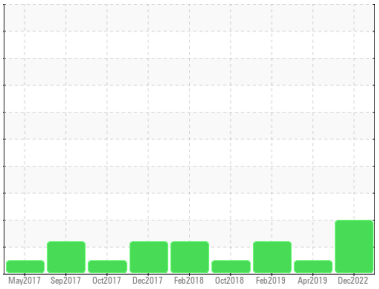
Sample Rating Trend

DEGRADATION

Due to the low reserve alkalinity it is advised that you contact HOUGHTON to assist in restoring the proper amine concentration. We recommend an early resample to monitor this condition. NOTE: Please provide information regarding reservoir capacity, filter type and micron rating with next sample.

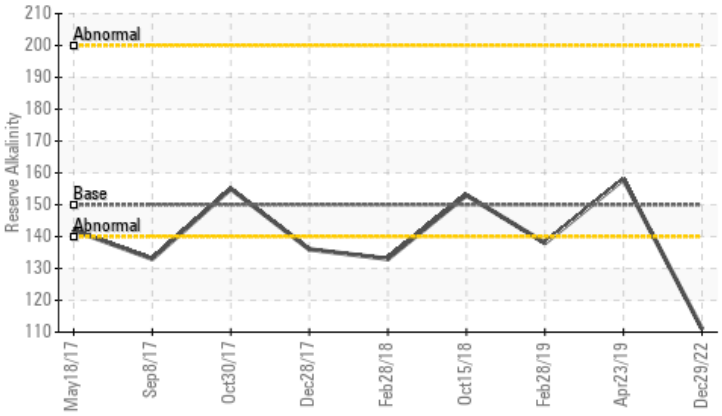
▲ Reserve Alkalinity

The reserve alkalinity of this fluid is lower than acceptable. The AN level is acceptable for this fluid. The pH level of this fluid is within the acceptable limits. The water concentration level is acceptable for this fluid.

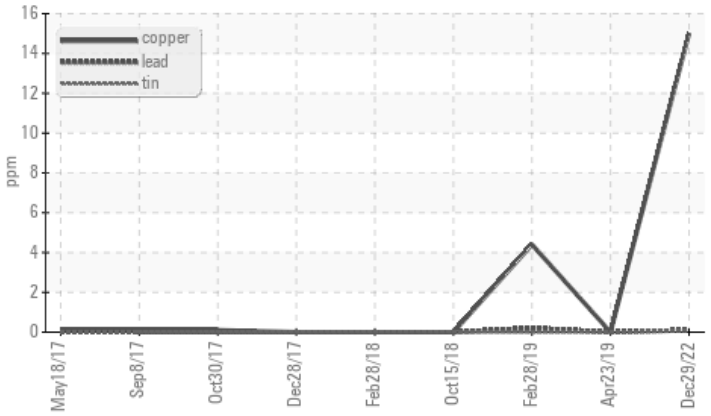
▲ Non-ferrous Metals

Copper ppm levels are noted. All other component wear rates are normal.

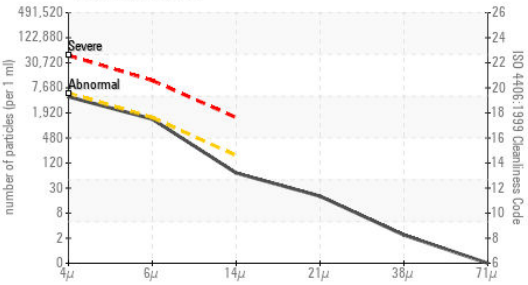
Particle Count

The system cleanliness is acceptable for your target ISO 4406 cleanliness code. The system and fluid cleanliness is acceptable.
