PROBLEM SUMMARY

Machine Id
SBK G1 TUBR (S/N 920)
Component
Bearing
Fluid
ESSO TERESSO ISO 68 (6 GAL)

Customer Id: NEWSTJ
Sample No.: WC0445345
Lab Number: 02535346
Test Package: IND 2

OIL ANALYSIS REPORT

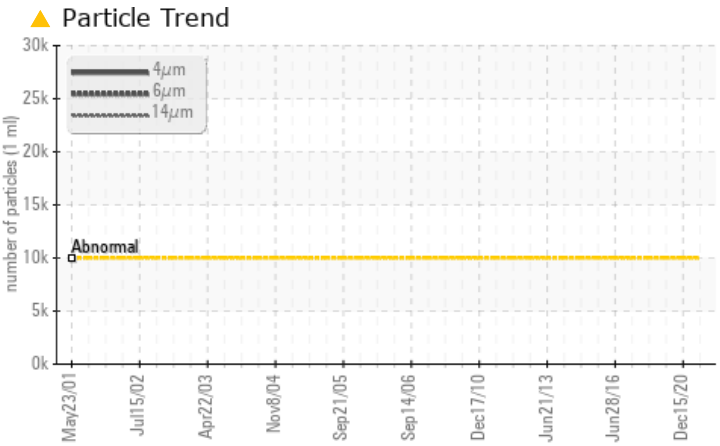
COMPONENT CONDITION SUMMARY

Sample Status				**ABNORMAL**	NORMAL	NORMAL
Particles >4µm		ASTM D7647	>10000	▲ **25228**	---	---
Particles >6µm		ASTM D7647	>2500	▲ **3508**	---	---
Oil Cleanliness		ISO 4406 (c)	>20/18/14	▲ **22/19/14**	---	---

Contamination
Particles >4µm and oil cleanliness are abnormally high. Particles >6µm are notably high.

We recommend you service the filters on this component. We recommend an early resample to monitor this condition.

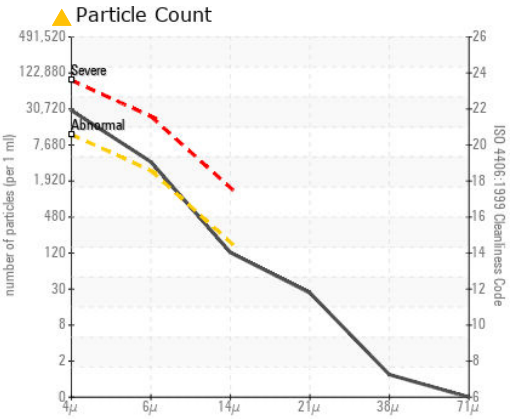
Particle Count

FLUID CLEANLINESS		method	limit/base	current	history1	history2
Particles >4µm		ASTM D7647	>10000	▲ **25228**	---	---
Particles >6µm		ASTM D7647	>2500	▲ **3508**	---	---
Particles >14µm		ASTM D7647	>160	**108**	---	---
Particles >21µm		ASTM D7647	>40	**23**	---	---
Particles >38µm		ASTM D7647	>10	**1**	---	---
Particles >71µm		ASTM D7647	>3	**0**	---	---
Oil Cleanliness		ISO 4406 (c)	>20/18/14	▲ **22/19/14**	---	---

Recommendation
We recommend you service the filters on this component. We recommend an early resample to monitor this condition.
