PROBLEM SUMMARY

Area
[197132]
Machine Id
LOK-G2-GEBR
Component
Bearing
Fluid
ESSO TERESSO ISO 68 (27 LTR)

OIL ANALYSIS REPORT

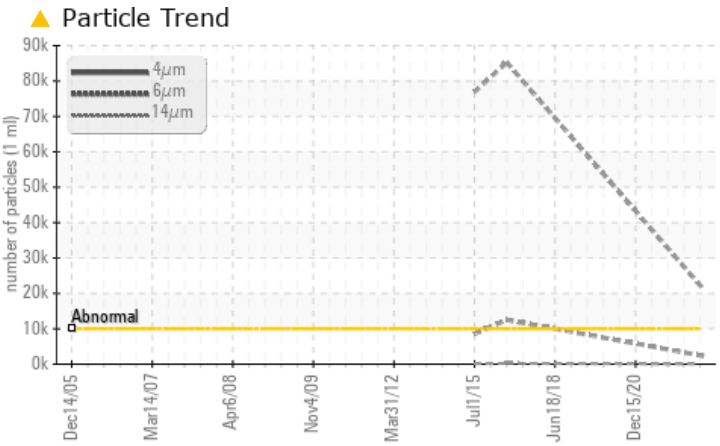
COMPONENT CONDITION SUMMARY

Sample Status				**ABNORMAL**	NORMAL	NORMAL
Particles >4µm		ASTM D7647	>10000	▲ **22315**	---	---
Oil Cleanliness		ISO 4406 (c)	>20/18/14	▲ **22/18/12**	---	---

Contamination
Particles >4µm and oil cleanliness are abnormally high.

We recommend you service the filters on this component. We recommend an early resample to monitor this condition.

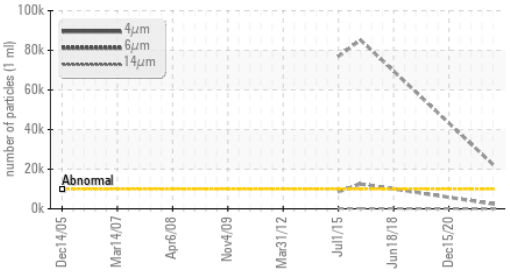
Particle Trend

FLUID CLEANLINESS		method	limit/base	current	history1	history2
Particles >4µm		ASTM D7647	>10000	▲ **22315**	---	---
Particles >6µm		ASTM D7647	>2500	**2472**	---	---
Particles >14µm		ASTM D7647	>160	**35**	---	---
Particles >21µm		ASTM D7647	>40	**4**	---	---
Particles >38µm		ASTM D7647	>10	**0**	---	---
Particles >71µm		ASTM D7647	>3	**0**	---	---
Oil Cleanliness		ISO 4406 (c)	>20/18/14	▲ **22/18/12**	---	---
