Area
TEAM 1
Machine Id
122553 Turbo Generator
Component
Hydraulic System
Fluid
PETRO CANADA TURBOFLO R&O 32 (1250 GAL)

Customer Id: CANDRY
Sample No.: WC0801832
Lab Number: 02548343
Test Package: AOM 3

OIL ANALYSIS REPORT

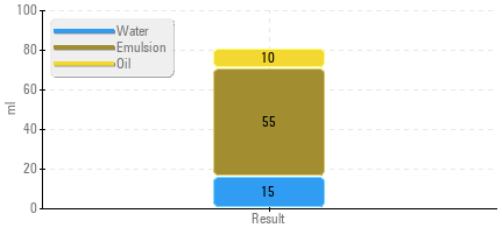
Sample Status				**SEVERE**	NORMAL	NORMAL
Separability	oil/h2o/em	ASTM D1401*	41/39/0	**10/15/55 (30)**	---	---

Water Separability results (ASTM D1401) are poor and indicate that the oil will form emulsions with water. The system cleanliness is acceptable for your target ISO 4406 cleanliness code. The water content is negligible.

We recommend that you perform vacuum distillation and/or air drying to attempt to remove any residual water and/or entrained gases from this oil that may be contributing to abnormal foaming and/or poor water separability. We recommend an early resample to monitor this condition.

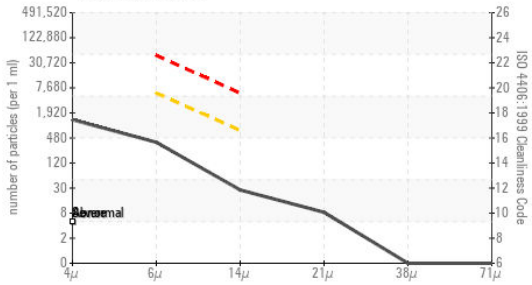
Particle Count

FLUID CLEANLINESS		method	limit/base	current	history1	history2
Particles >4µm		ASTM D7647		**1156**	715	1309
Particles >6µm		ASTM D7647	>5000	**333**	187	341
Particles >14µm		ASTM D7647	>640	**24**	18	16
Particles >21µm		ASTM D7647	>160	**7**	6	3
Particles >38µm		ASTM D7647	>40	**0**	0	0
Particles >71µm		ASTM D7647	>10	**0**	0	0
Oil Cleanliness		ISO 4406 (c)	>--/19/16	**17/16/12**	17/15/11	18/16/11

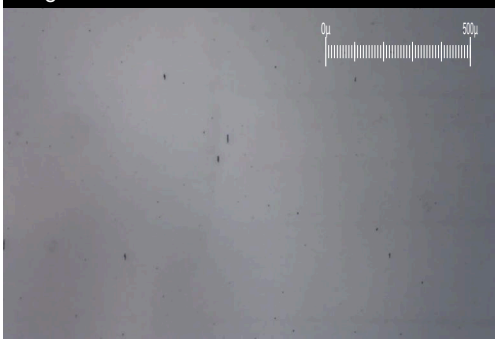
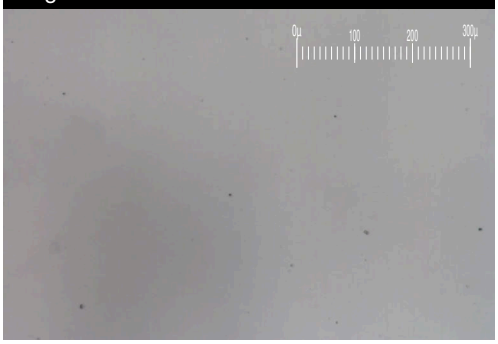
FERROGRAPHY REPORT

All component wear rates are normal. The direct-reading & analytical ferrographic results are normal indicating no abnormal wear in the system.
