Machine Id
MAIN HPU
Component
Hydraulic System
Fluid
CHEVRON RANDO HD 46 (--- LTR)

Customer Id: BREABB
Sample No.: WC0732081
Lab Number: 02551419
Test Package: IND 2

OIL ANALYSIS REPORT

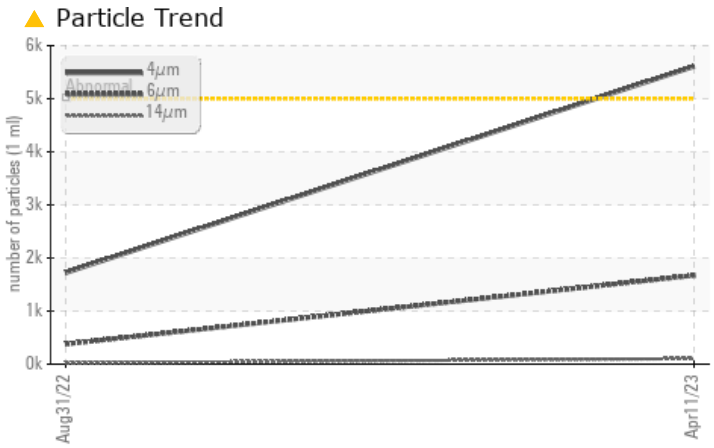
COMPONENT CONDITION SUMMARY

Sample Status				**ATTENTION**	NORMAL	---
Particles >4µm		ASTM D7647	>5000	▲ **5608**	1720	---
Particles >6µm		ASTM D7647	>1300	▲ **1672**	378	---
Oil Cleanliness		ISO 4406 (c)	>19/17/14	▲ **20/18/14**	18/16/12	---

Contamination
There is a light amount of silt (particulates < 14 microns in size) present in the oil.

We recommend you service the filters on this component. Resample at the next service interval to monitor. NOTE: Please provide information regarding reservoir capacity, filter type and micron rating with next sample.

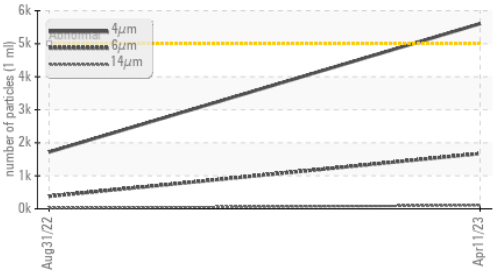
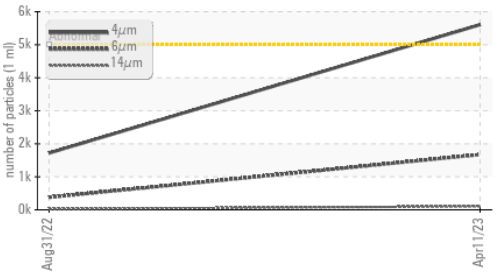
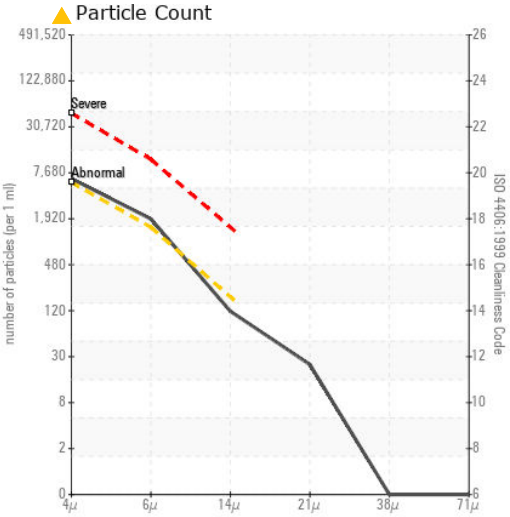
FLUID CLEANLINESS		method	limit/base	current	history1	history2
Particles >4µm		ASTM D7647	>5000	▲ **5608**	1720	---
Particles >6µm		ASTM D7647	>1300	▲ **1672**	378	---
Particles >14µm		ASTM D7647	>160	**104**	21	---
Particles >21µm		ASTM D7647	>40	**21**	5	---
Particles >38µm		ASTM D7647	>10	**0**	0	---
Particles >71µm		ASTM D7647	>3	**0**	0	---
Oil Cleanliness		ISO 4406 (c)	>19/17/14	▲ **20/18/14**	18/16/12	---

Recommendation
We recommend you service the filters on this component. Resample at the next service interval to monitor. NOTE: Please provide information regarding reservoir capacity, filter type and micron rating with next sample.

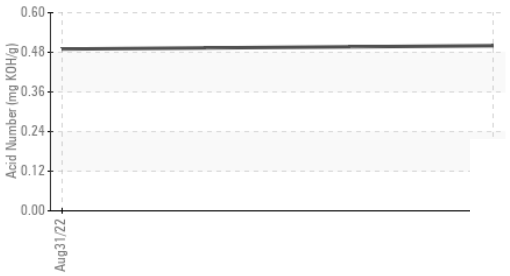
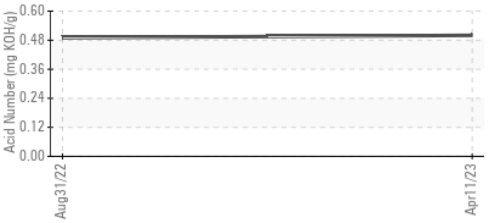
Acid Number

Fluid Condition
The AN level is acceptable for this fluid. The condition of the oil is suitable for further service.

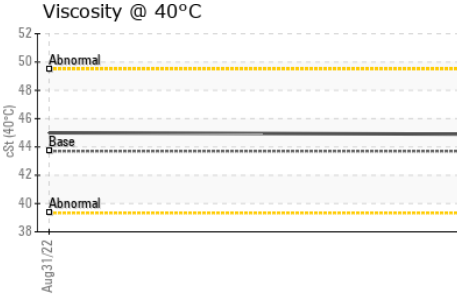
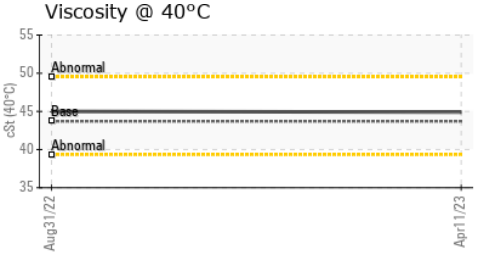
Viscosity @ 40°C

FLUID PROPERTIES		method	limit/base	current	history1	history2
Visc @ 40°C	cSt	ASTM D7279(m)	43.7	**44.9**	45.0	---

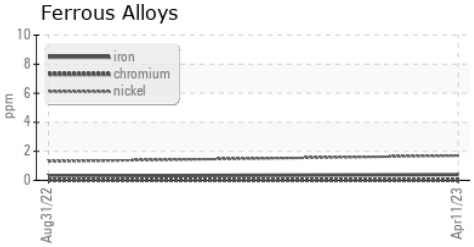
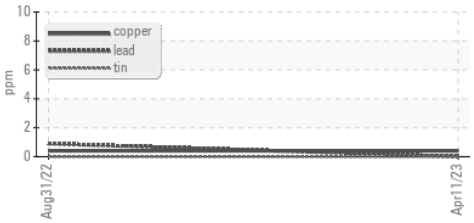
Wear
All component wear rates are normal.
