OIL ANALYSIS REPORT

Machine Id
MITCHELL SCG1 UB
Component
Bearing
Fluid
SHELL TURBO T ISO 46 (--- LTR)

Laboratory : WearCheck - C8-1175 Appleby Line, Burlington, ON L7L 5H9 **Sechelt Creek Station (Regional Power)**
Sample No. : WC0793123 **Received** : 28 Apr 2023 Unit 1A-5764 Wharf Road
Lab Number : 02554193 **Diagnosed** : 02 May 2023 Sechelt Creek, BC
Unique Number : 5567208 **Diagnostician** : Kevin Marson CA V0N 3A0
Test Package : IND 2 (Additional Tests: PRTCOUNT, TAN Man) Contact: Cory Mottishaw
corymsgs@gmail.com

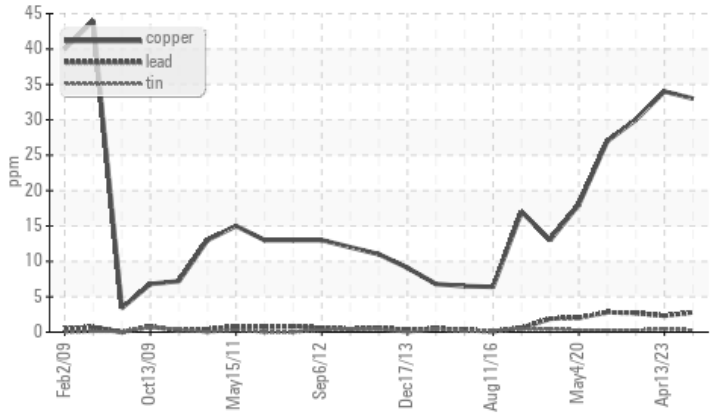
▲ Non-ferrous Metals

Sample Status				**ATTENTION**	ATTENTION	ATTENTION
Copper	ppm	ASTM D5185(m)	>20	▲ **33**	▲ 34	▲ 30

▲ Wear
Copper ppm levels are noted. All other component wear rates are normal.

Resample at the next service interval to monitor.
NOTE: Please provide information regarding reservoir capacity, filter type and micron rating with next sample.

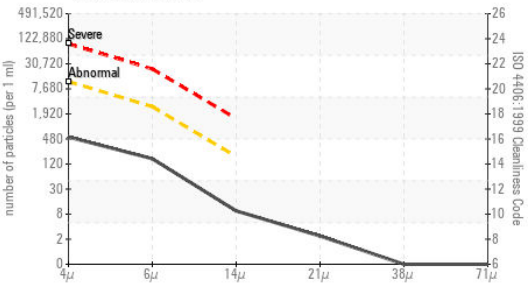
Particle Count

Contamination
The system cleanliness is acceptable for your target ISO 4406 cleanliness code. The system and fluid cleanliness is acceptable.

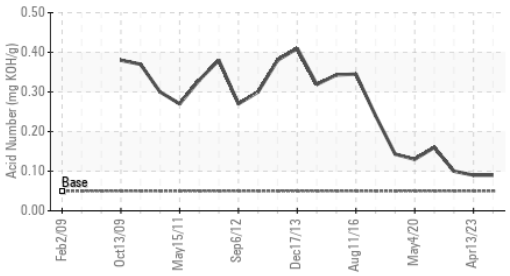
Acid Number

Fluid Condition
The AN level is acceptable for this fluid. The condition of the oil is suitable for further service.
