OIL ANALYSIS REPORT

Area
Lac Seul GS
Machine Id
FP5-G1 HP Governor
Component
Governor System
Fluid
ESSO NUTO H ISO 68 (--- GAL)

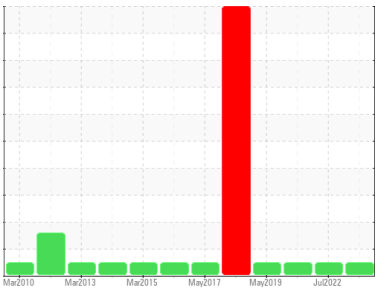
Sample Rating Trend

NORMAL

Wear
All component wear rates are normal.

Contamination
The system cleanliness is acceptable for your target ISO 4406 cleanliness code. The system and fluid cleanliness is acceptable.

Fluid Condition
The AN level is acceptable for this fluid. The condition of the oil is suitable for further service.

Recommendation
Resample at the next service interval to monitor. NOTE: Please provide information regarding reservoir capacity, filter type and micron rating with next sample.

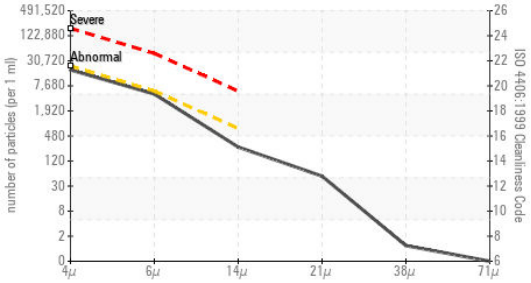
Particle Count

FLUID CLEANLINESS		method	limit/base	current	history1	history2
Particles >4µm		ASTM D7647	>20000	**16128**	621	19883
Particles >6µm		ASTM D7647	>5000	**4258**	68	4499
Particles >14µm		ASTM D7647	>640	**229**	5	445
Particles >21µm		ASTM D7647	>160	**46**	1	221
Particles >38µm		ASTM D7647	>40	**1**	0	36
Particles >71µm		ASTM D7647	>10	**0**	0	7
Oil Cleanliness		ISO 4406 (c)	>21/19/16	**21/19/15**	16/13/10	21/19/16

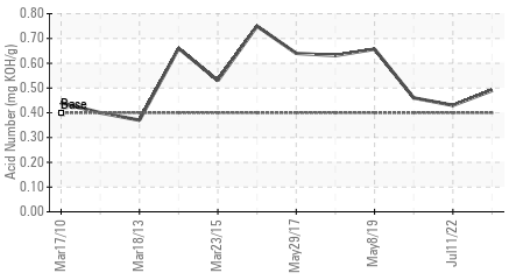
FLUID DEGRADATION		method	limit/base	current	history1	history2
Acid Number (AN)	mg KOH/g	ASTM D974*	.40	**0.49**	0.43	0.46

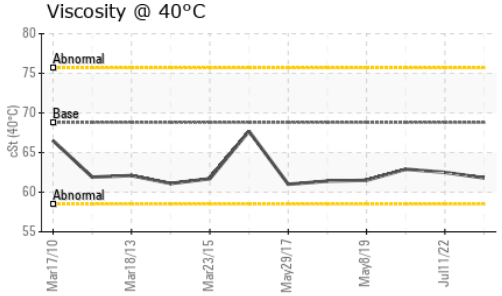
Viscosity @ 40°C

FLUID PROPERTIES		method	limit/base	current	history1	history2
Visc @ 40°C	cSt	ASTM D7279(m)	68.8	**61.8**	62.5	62.9

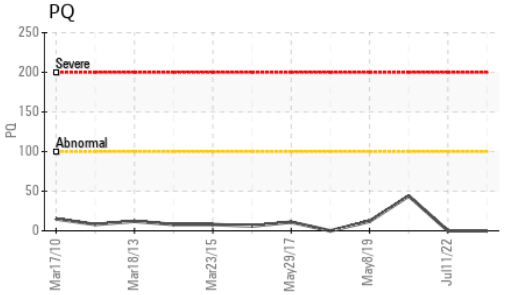
WEAR METALS		method	limit/base	current	history1	history2
PQ		ASTM D8184*		**0**	0	44
Iron	ppm	ASTM D5185(m)	>50	**4**	7	7
Chromium	ppm	ASTM D5185(m)	>10	**0**	0	0
Nickel	ppm	ASTM D5185(m)	>10	**0**	<1	<1
Titanium	ppm	ASTM D5185(m)		**0**	0	0
Silver	ppm	ASTM D5185(m)		**0**	0	0
Aluminum	ppm	ASTM D5185(m)	>3	**<1**	<1	0
Lead	ppm	ASTM D5185(m)	>75	**<1**	1	<1
Copper	ppm	ASTM D5185(m)	>15	**7**	12	12
Tin	ppm	ASTM D5185(m)	>55	**<1**	<1	<1
Antimony	ppm	ASTM D5185(m)	>5	**0**	0	<1
Vanadium	ppm	ASTM D5185(m)		**0**	0	0
Beryllium	ppm	ASTM D5185(m)		**0**	0	0
Cadmium	ppm	ASTM D5185(m)		**0**	0	0
