PROBLEM SUMMARY

Area
MANITOU FALLS GS
Machine Id
FP2G1
Component
Turbine Bearing
Fluid
ESSO TERESSO ISO 46 (--- GAL)

Customer Id: ONTKEE
Sample No.: WC0806461
Lab Number: 02558994
Test Package: IND 2

OIL ANALYSIS REPORT

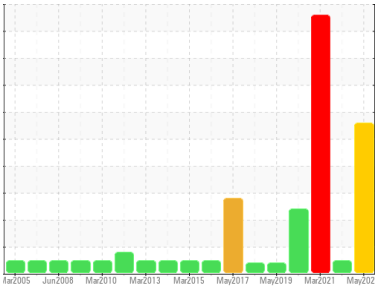
Sample Rating Trend

Sample Status				SEVERE	NORMAL	SEVERE
Lead	ppm	ASTM D5185(m)	>20	▲ **21**	17	▲ 22
Particles >4µm		ASTM D7647	>10000	⬢ **99877**	4623	⬢ 145563
Particles >6µm		ASTM D7647	>2500	⬢ **32593**	277	⬢ 64479
Particles >14µm		ASTM D7647	>160	▲ **1228**	3	⬢ 6630
Particles >21µm		ASTM D7647	>40	▲ **267**	1	⬢ 1555
Particles >38µm		ASTM D7647	>10	▲ **17**	0	⬢ 90
Oil Cleanliness		ISO 4406 (c)	>20/18/14	⬢ **24/22/17**	19/15/9	⬢ 24/23/20

We advise that you check all areas where contaminants can enter the system. We advise that you perform a filter service, and use off-line filtration to improve the cleanliness of the system fluid. The air breather requires service. If unrated, we recommend that you replace with a suitable micron rated and/or desiccant air breather. If rated, we recommend that you service/replace the breather. Resample in 30-45 days to monitor this situation. NOTE: Please provide information regarding reservoir capacity, filter type and micron rating with next sample.

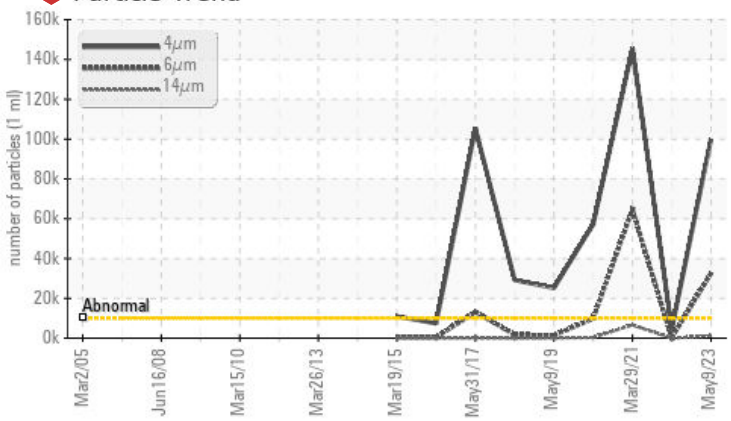
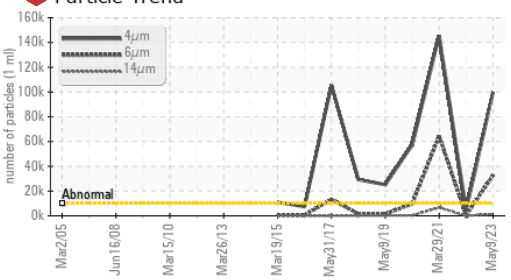
Particle Trend

There is a high amount of particulates (2 to 100 microns in size) present in the oil.

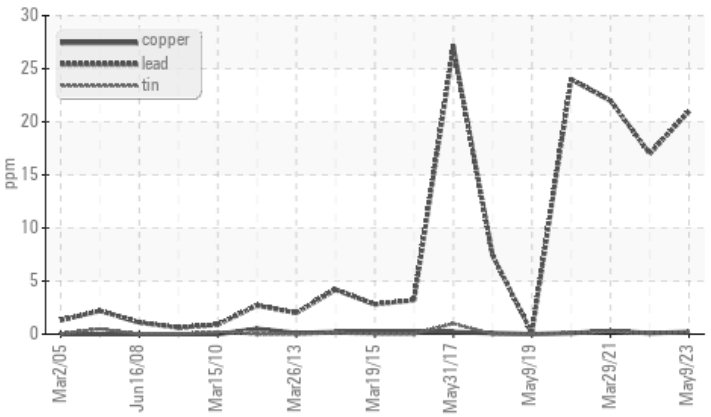
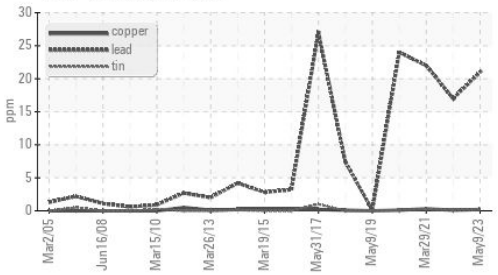
Non-ferrous Metals

Lead ppm levels are abnormal. Bearing wear is indicated.

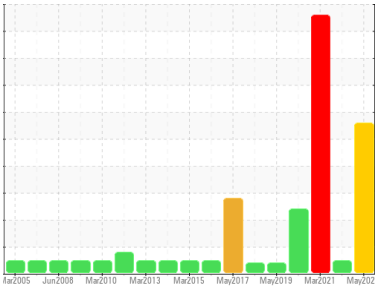
Sample Rating Trend

The AN level is acceptable for this fluid. The oil is no longer serviceable as a result of the abnormal and/or severe wear.

We advise that you check all areas where contaminants can enter the system. We advise that you perform a filter service, and use off-line filtration to improve the cleanliness of the system fluid. The air breather requires service. If unrated, we recommend that you replace with a suitable micron rated and/or desiccant air breather. If rated, we recommend that you service/replace the breather. Resample in 30-45 days to monitor this situation. NOTE: Please provide information regarding reservoir capacity, filter type and micron rating with next sample.

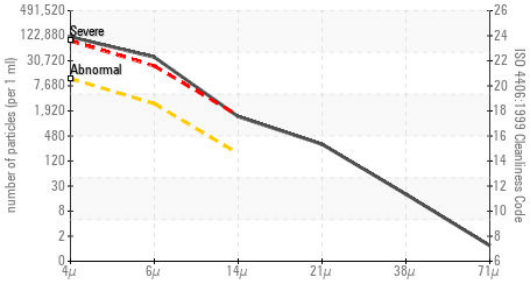
Particle Count

FLUID CLEANLINESS		method	limit/base	current	history1	history2
Particles >4µm		ASTM D7647	>10000	**99877**	4623	145563
Particles >6µm		ASTM D7647	>2500	**32593**	277	64479
Particles >14µm		ASTM D7647	>160	**1228**	3	6630
Particles >21µm		ASTM D7647	>40	**267**	1	1555
Particles >38µm		ASTM D7647	>10	**17**	0	90
Particles >71µm		ASTM D7647	>3	**1**	0	5
Oil Cleanliness		ISO 4406 (c)	>20/18/14	**24/22/17**	19/15/9	24/23/20
