OIL ANALYSIS REPORT

Area
EAR FALLS GS
Machine Id
FP1G4
Component
Thrust Bearing
Fluid
ESSO TERESSO ISO 46 (--- GAL)

SAMPLE INFORMATION		method	limit/base	current	history1	history2
Sample Number		Client Info		**WC0806455**	WC0686269	WC0560613
Sample Date		Client Info		**22 May 2023**	11 Jul 2022	03 May 2021
Machine Age	hrs	Client Info		**0**	0	0
Oil Age	hrs	Client Info		**0**	0	0
Oil Changed		Client Info		**N/A**	N/A	N/A
Sample Status				**NORMAL**	ATTENTION	SEVERE

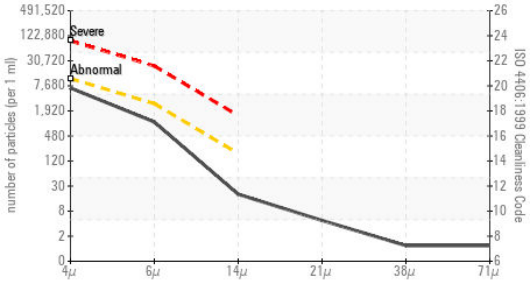
Particle Count

Contamination
The system cleanliness is acceptable for your target ISO 4406 cleanliness code. The system and fluid cleanliness is acceptable.

FLUID CLEANLINESS		method	limit/base	current	history1	history2
Particles >4µm		ASTM D7647	>10000	**5957**	▲ 10788	⬢ 89850
Particles >6µm		ASTM D7647	>2500	**912**	1352	▲ 19736
Particles >14µm		ASTM D7647	>160	**17**	38	▲ 849
Particles >21µm		ASTM D7647	>40	**4**	9	▲ 172
Particles >38µm		ASTM D7647	>10	**1**	2	9
Particles >71µm		ASTM D7647	>3	**1**	0	0
Oil Cleanliness		ISO 4406 (c)	>20/18/14	**20/17/11**	▲ 21/18/12	⬢ 24/21/17

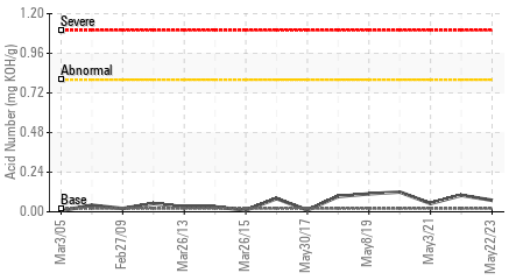
Fluid Condition
The AN level is acceptable for this fluid. The condition of the oil is suitable for further service.

FLUID DEGRADATION		method	limit/base	current	history1	history2
Acid Number (AN)	mg KOH/g	ASTM D974*	0.02	**0.07**	0.10	0.05

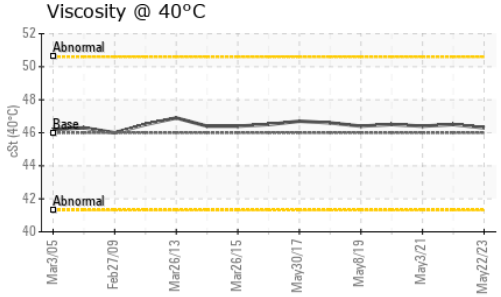
Viscosity @ 40°C

FLUID PROPERTIES		method	limit/base	current	history1	history2
Visc @ 40°C	cSt	ASTM D7279(m)	46	**46.3**	46.5	46.4

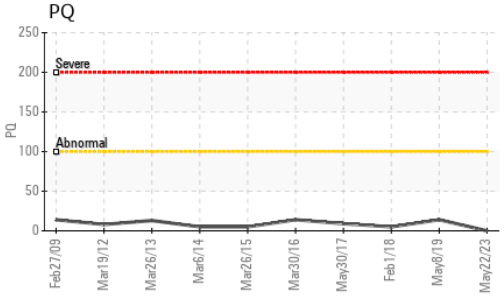
PQ

Wear
All component wear rates are normal.
