Customer Id: TOYCAM
Sample No.: CB0031224
Lab Number: 02562372
Test Package: IND 3

OIL ANALYSIS REPORT

Machine Id
TIMM 1 A BARREL
Component
Gearbox
Fluid
SHELL OMALA 68 (--- GAL)

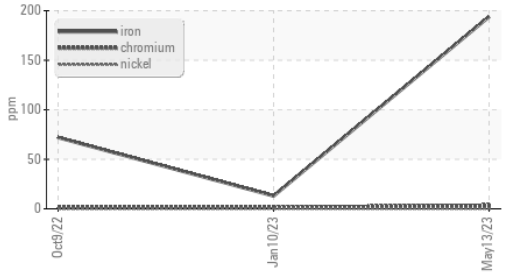
Ferrous Alloys

Iron ppm levels are abnormal. Wear particle analysis indicates that the ferrous rubbing particles are marginal. A sharp increase in the iron level is noted. All other component wear rates are normal.

The oil change at the time of sampling has been noted. We recommend an early resample to monitor this condition. No other corrective action is recommended at this time. NOTE: Please provide information regarding reservoir capacity, filter type and micron rating with next sample.

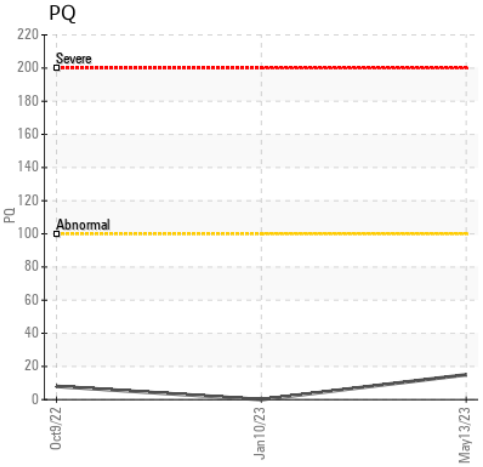
WEAR METALS		method	limit/base	current	history1	history2
PQ		ASTM D8184*		**15**	0	8
Iron	ppm	ASTM D5185(m)	>200	▲ **194**	13	72
Chromium	ppm	ASTM D5185(m)	>15	**4**	1	2
Nickel	ppm	ASTM D5185(m)	>15	**<1**	<1	<1
Titanium	ppm	ASTM D5185(m)		**0**	0	0
Silver	ppm	ASTM D5185(m)		**0**	0	0
Aluminum	ppm	ASTM D5185(m)	>25	**<1**	<1	<1
Lead	ppm	ASTM D5185(m)	>100	**0**	<1	<1
Copper	ppm	ASTM D5185(m)	>200	**1**	2	9
Tin	ppm	ASTM D5185(m)	>25	**0**	0	0
Antimony	ppm	ASTM D5185(m)	>5	**0**	<1	0
Vanadium	ppm	ASTM D5185(m)		**0**	0	0
Beryllium	ppm	ASTM D5185(m)		**0**	0	0
Cadmium	ppm	ASTM D5185(m)		**0**	0	0

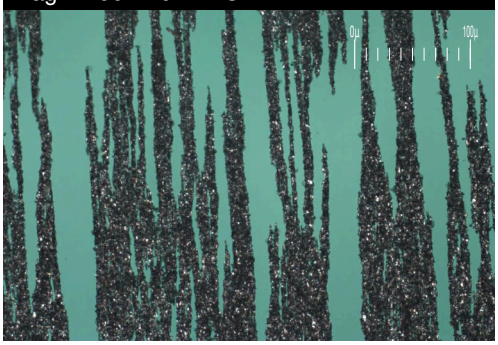
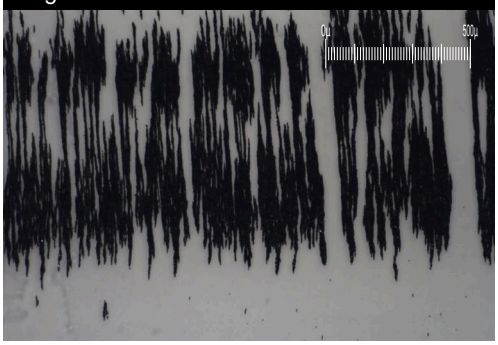
Iron ppm levels are abnormal. Wear particle analysis indicates that the ferrous rubbing particles are marginal. A sharp increase in the iron level is noted. All other component wear rates are normal.

The oil change at the time of sampling has been noted. We recommend an early resample to monitor this condition. No other corrective action is recommended at this time. NOTE: Please provide information regarding reservoir capacity, filter type and micron rating with next sample.
