OIL ANALYSIS REPORT

Machine Id
TIMM #1 PLUNGER 1
Component
Gearbox
Fluid
SHELL OMALA S2 G 68 (--- GAL)

FERROGRAPHY REPORT

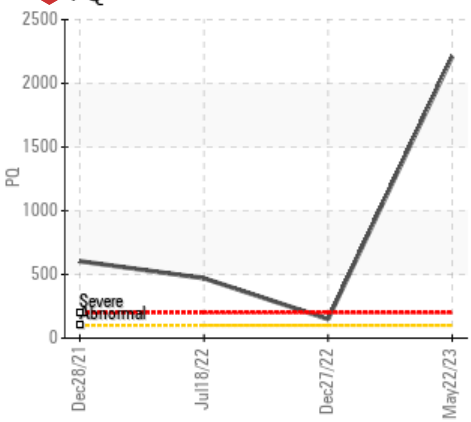
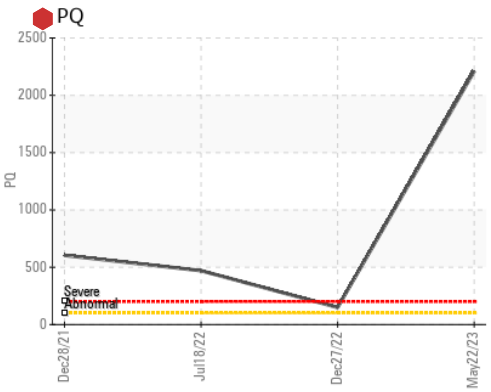
Iron ppm levels are severe. PQ levels are severe. Severity Index and large particles and large particles percentage levels are abnormal. Wear particle analysis indicates that the ferrous rubbing particles are abnormal. Gear wear is indicated. The very high ferrous density (PQ) index indicates that severe wear is occurring.

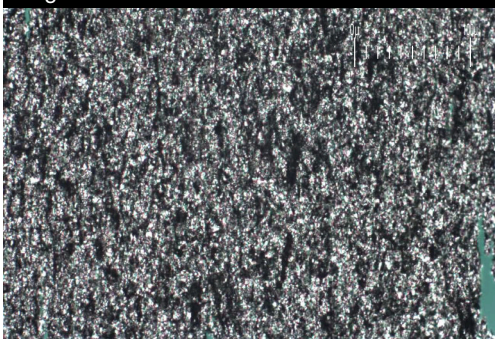
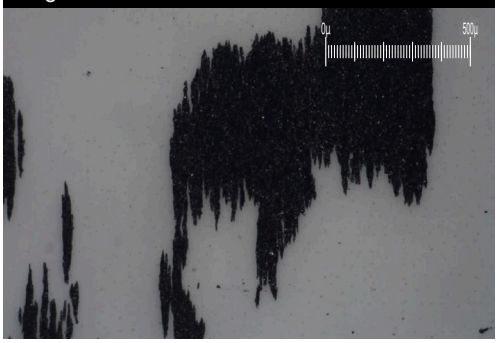
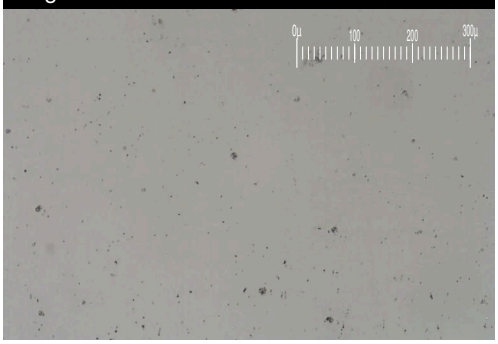
Iron ppm levels are severe. PQ levels are severe. Severity Index and large particles and large particles percentage levels are abnormal. Wear particle analysis indicates that the ferrous rubbing particles are abnormal. Gear wear is indicated. The very high ferrous density (PQ) index indicates that severe wear is occurring.

The oil change at the time of sampling has been noted. We recommend an early resample to monitor this condition. NOTE: Please provide information regarding reservoir capacity, filter type and micron rating with next sample.
