PROBLEM SUMMARY

Area
ENGINE ROOM 3RD DECK
Machine Id
27-K-6410B MAIN AIR COMPRESSOR B (S/N Maint Plan 22465)
Component
2 Air Compressor
Fluid
MOBIL RARUS 826 (4 LTR)

OIL ANALYSIS REPORT

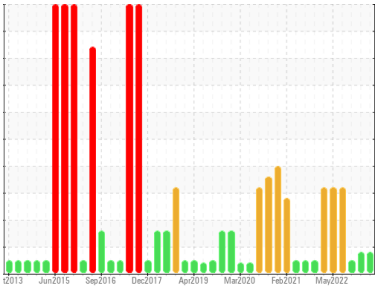
Sample Rating Trend

WEAR

Sample Status				ATTENTION	ATTENTION	NORMAL
Aluminum	ppm	ASTM D5185(m)	>10	▲ 21	▲ 21	10

No corrective action is recommended at this time. We recommend an early resample to monitor this condition.

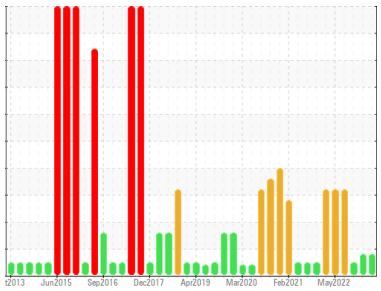
Sample Rating Trend

WEAR

Aluminum ppm levels are noted. All other component wear rates are normal.

There is no indication of any contamination in the oil.

The condition of the oil is acceptable for the time in service.

No corrective action is recommended at this time. We recommend an early resample to monitor this condition.
