Area
BRUCE B/0B/54600
Machine Id
0B-54600-SG8-Avon Level Gauge
Component
Jet Turbine
Fluid
SHELL AEROSHELL 500 (--- GAL)

Customer Id: BRUTIV
Sample No.: WC0548191
Lab Number: 02565561
Test Package: IND2+

OIL ANALYSIS REPORT

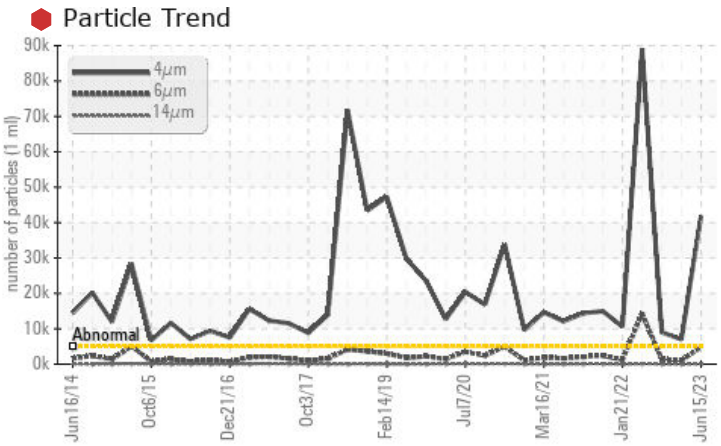
COMPONENT CONDITION SUMMARY

Wear particle analysis indicates that the ferrous cutting particles are marginal. All other component wear rates are normal. Cutting wear particles are caused by either hard protuberances (mis-aligned components, etc.), or abrasives entering the system and embeding themselves in softer materials (sand, etc.), and gouging out mating surfaces.

There is a high amount of silt (particulates < 14 microns in size) present in the oil. The water content is negligible. The system cleanliness code is much higher than the acceptable limit for the target ISO 4406 cleanliness code.

The AN level is acceptable for this fluid. The oil is still serviceable provided that the contaminant(s) can be reduced to acceptable levels.

Check seals and/or filters for points of contaminant entry. The air breather requires service. If unrated, we recommend that you replace with a suitable micron rated and/or desiccant air breather. If rated, we recommend that you service/replace the breather. We recommend you service the filters on this component. Resample in 30-45 days to monitor this situation. No other corrective action is recommended at this time. NOTE: Please provide information regarding reservoir capacity, filter type and micron rating with next sample.

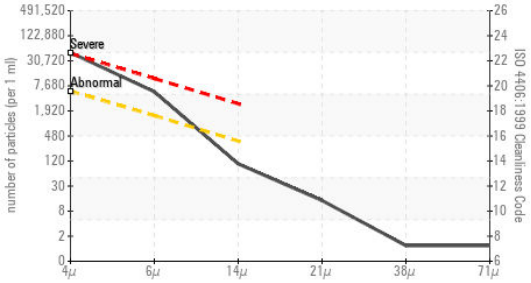
Particle Count

FLUID CLEANLINESS		method	limit/base	current	history1	history2
Particles >4µm		ASTM D7647	>5000	**41768**	7031	8988
Particles >6µm		ASTM D7647	>1300	**4844**	1021	1442
Particles >14µm		ASTM D7647	>320	**91**	33	39
Particles >21µm		ASTM D7647	>80	**12**	8	7
Particles >38µm		ASTM D7647	>20	**1**	1	0
Particles >71µm		ASTM D7647	>4	**1**	1	0
Oil Cleanliness		ISO 4406 (c)	>19/17/15	**23/19/14**	20/17/12	20/18/12

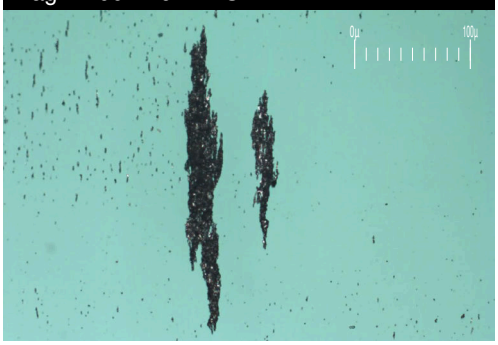
Magn: 200x Illum: BC

Wear particle analysis indicates that the ferrous cutting particles are marginal. All other component wear rates are normal. Cutting wear particles are caused by either hard protuberances (mis-aligned components, etc.), or abrasives entering the system and embeding themselves in softer materials (sand, etc.), and gouging out mating surfaces.
