Area
Direct Strip Mill/Finishing
Machine Id
HSM WEST GLYCOL BLK (S/N DSC 196)
Component
Hydraulic System
Fluid
HOUGHTON HOUGHTON SAFE 616 (--- GAL)

Customer Id: ALGSSM
Sample No.: WC0780857
Lab Number: 02575517
Test Package: IND 2

OIL ANALYSIS REPORT

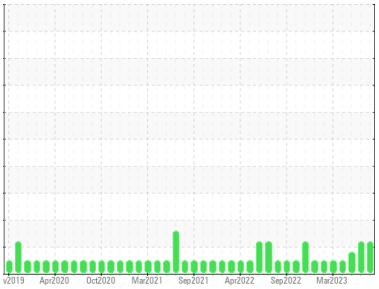
Sample Rating Trend

DEGRADATION

The reserve alkalinity of this fluid is lower than acceptable. The AN level is acceptable for this fluid. The pH level of this fluid is within the acceptable limits. The water concentration level is acceptable for this fluid.

Due to the low reserve alkalinity it is advised that you contact HOUGHTON to assist in restoring the proper amine concentration. We recommend an early resample to monitor this condition. NOTE: Please provide information regarding reservoir capacity, filter type and micron rating with next sample.

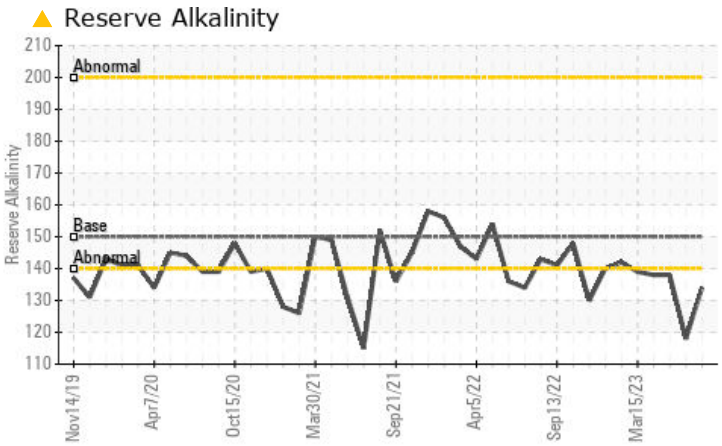
COMPONENT CONDITION SUMMARY

Sample Status				ABNORMAL	ABNORMAL	ATTENTION
Alkiline Reserve (Oils)	ml KOH/g	ASTM D1121*	150	▲ 134	▲ 118	138

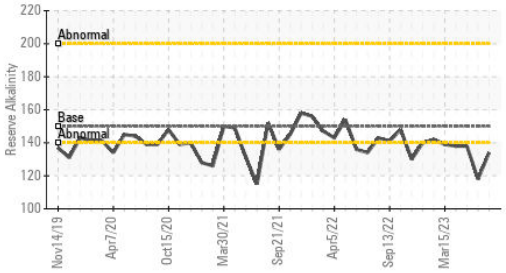
Reserve Alkalinity

FLUID DEGRADATION		method	limit/base	current	history1	history2
Acid Number (AN)	mg KOH/g	ASTM D974*		**4.22**	4.66	4.48
Alkiline Reserve (Oils)	ml KOH/g	ASTM D1121*	150	▲ **134**	▲ 118	138

Due to the low reserve alkalinity it is advised that you contact HOUGHTON to assist in restoring the proper amine concentration. We recommend an early resample to monitor this condition. NOTE: Please provide information regarding reservoir capacity, filter type and micron rating with next sample.

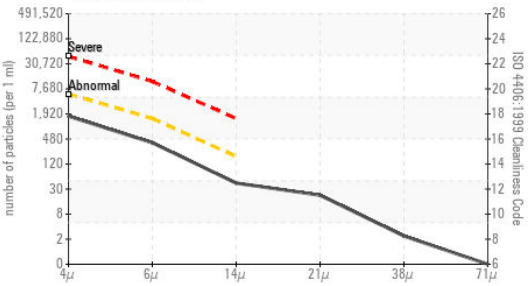
Particle Count

The system cleanliness is acceptable for your target ISO 4406 cleanliness code. The system and fluid cleanliness is acceptable.

FLUID CLEANLINESS		method	limit/base	current	history1	history2
Particles >4µm		ASTM D7647	>5000	**1487**	2010	1305
Particles >6µm		ASTM D7647	>1300	**343**	341	266
Particles >14µm		ASTM D7647	>160	**37**	5	12
Particles >21µm		ASTM D7647	>40	**19**	3	3
Particles >38µm		ASTM D7647	>10	**2**	0	0
Particles >71µm		ASTM D7647	>3	**0**	0	0
Oil Cleanliness		ISO 4406 (c)	>19/17/14	**18/16/12**	18/16/10	18/15/11

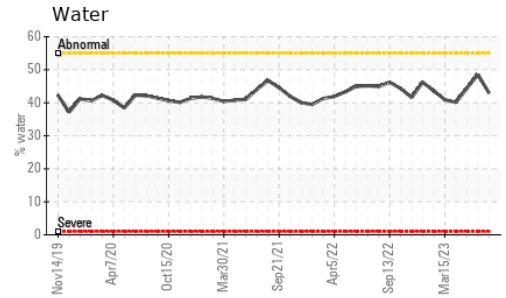
CONTAMINANTS		method	limit/base	current	history1	history2
Silicon	ppm	ASTM D5185(m)	>15	**0**	0	5
Sodium	ppm	ASTM D5185(m)		**14**	24	44
Potassium	ppm	ASTM D5185(m)	>20	**17**	12	49
Water	%	ASTM D6304*	>55	**42.9**	48.5	44.4
ppm Water	ppm	ASTM D6304*	>55000	**429000**	485000	444000
