Area
Direct Strip Mill/Caster
Machine Id
CH3 HYDRAULIC SYSTEM (DSC192) (S/N 1000024570)
Component
Hydraulic System
Fluid
HOUGHTON HOUGHTO-SAFE 620 (6800 LTR)

Customer Id: ALGSSM
Sample No.: WC0813754
Lab Number: 02575518
Test Package: IND 2

OIL ANALYSIS REPORT

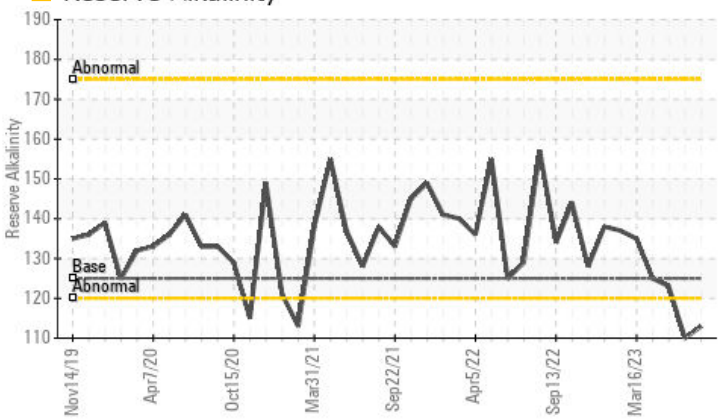
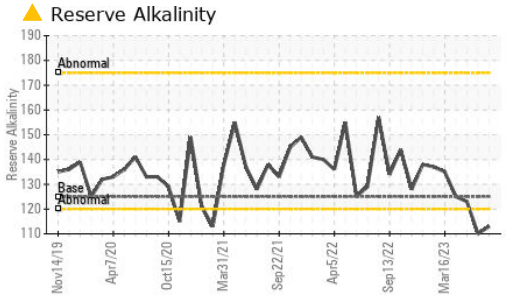
Reserve Alkalinity

The reserve alkalinity of this fluid is lower than acceptable. The AN level is acceptable for this fluid. The pH level of this fluid is within the acceptable limits. The water concentration level is acceptable for this fluid. The oil is still serviceable provided that the contaminant(s) can be reduced to acceptable levels.

Due to the low reserve alkalinity it is advised that you contact HOUGHTON to assist in restoring the proper amine concentration. We advise that you perform a filter service, and use off-line filtration to improve the cleanliness of the system fluid. We recommend an early resample to monitor this condition.

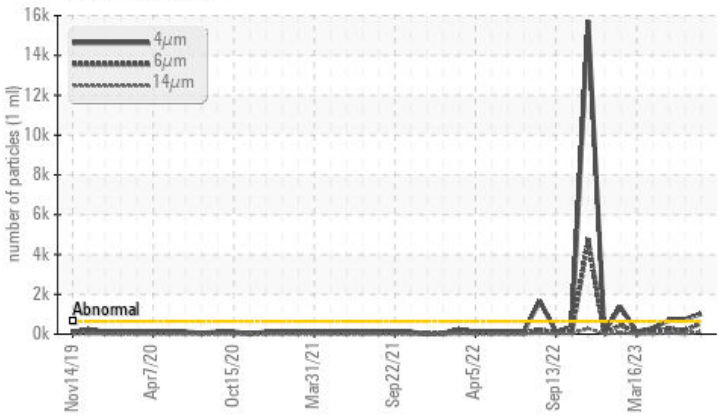
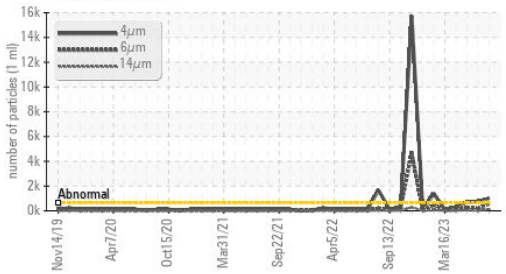
Particle Trend

There is a moderate amount of particulates (2 to 100 microns in size) present in the oil. The system cleanliness is above the acceptable limit for the target ISO 4406 cleanliness code.

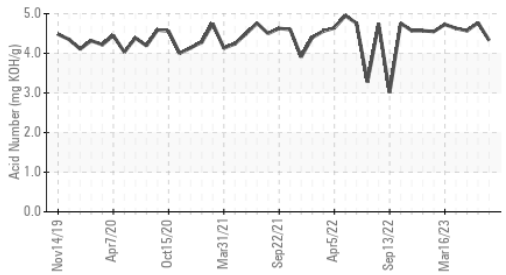
Acid Number

Fluid Condition
