Area
Direct Strip Mill/Caster
Machine Id
CH1 HYDRAULIC SYSTEM (DSC024) (S/N 1000024394)
Component
Hydraulic System
Fluid
HOUGHTON HOUGHTON SAFE 616 (3080 LTR)

Customer Id: ALGSSM
Sample No.: WC0813751
Lab Number: 02575522
Test Package: IND 2

OIL ANALYSIS REPORT

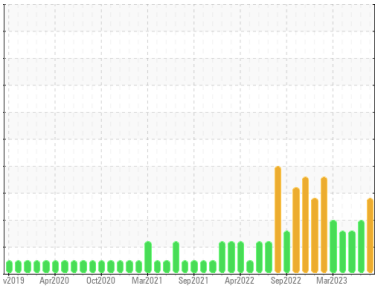
Sample Rating Trend

DEGRADATION

Sample Status				**ABNORMAL**	ABNORMAL	ABNORMAL
Particles >14µm		ASTM D7647	>20	▲ **27**	16	15
Particles >21µm		ASTM D7647	>4	▲ **9**	▲ 7	5
Oil Cleanliness		ISO 4406 (c)	>16/14/11	▲ **16/14/12**	▲ 18/15/11	15/13/11
Alkiline Reserve (Oils)	ml KOH/g	ASTM D1121*	150	▲ **123**	142	▲ 125
Visc @ 40°C	cSt	ASTM D7279(m)		▲ **33.2**	▲ 33.5	▲ 33.7

Due to the low reserve alkalinity it is advised that you contact HOUGHTON to assist in restoring the proper amine concentration. We recommend you service the filters on this component. We recommend an early resample to monitor this condition.

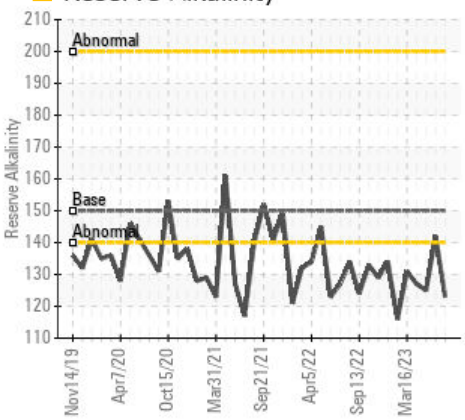
▲ Reserve Alkalinity

The reserve alkalinity of this fluid is lower than acceptable. Viscosity of sample indicates oil is within ISO 32 range, advise investigate. The AN level is acceptable for this fluid. The pH level of this fluid is within the acceptable limits. The water concentration level is acceptable for this fluid.

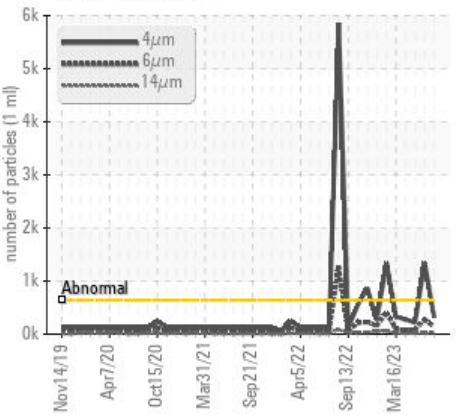
▲ Particle Trend

There is a light amount of silt (particulates < 14 microns in size) present in the oil.

FLUID CLEANLINESS		method	limit/base	current	history1	history2
Particles >4µm		ASTM D7647	>640	**321**	▲ 1344	218
Particles >6µm		ASTM D7647	>160	**139**	▲ 275	80
Particles >14µm		ASTM D7647	>20	▲ **27**	16	15
Particles >21µm		ASTM D7647	>4	▲ **9**	▲ 7	5
Particles >38µm		ASTM D7647	>3	**2**	2	0
Particles >71µm		ASTM D7647	>3	**0**	0	0
Oil Cleanliness		ISO 4406 (c)	>16/14/11	▲ **16/14/12**	▲ 18/15/11	15/13/11

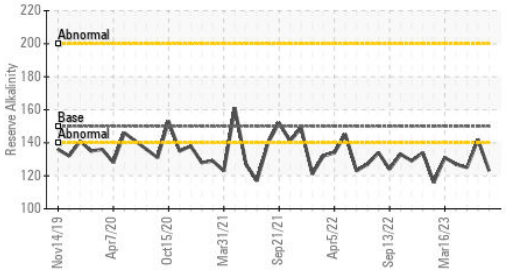
Reserve Alkalinity

FLUID DEGRADATION		method	limit/base	current	history1	history2
Acid Number (AN)	mg KOH/g	ASTM D974*		**4.52**	4.86	4.61
Alkiline Reserve (Oils)	ml KOH/g	ASTM D1121*	150	▲ **123**	142	▲ 125

Due to the low reserve alkalinity it is advised that you contact HOUGHTON to assist in restoring the proper amine concentration. We recommend you service the filters on this component. We recommend an early resample to monitor this condition.

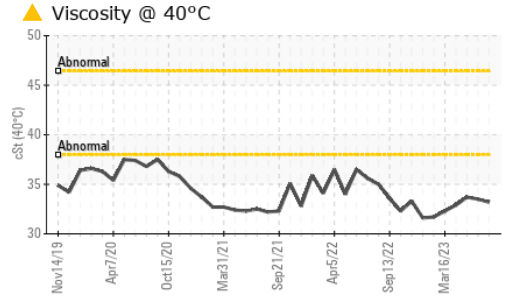
Viscosity @ 40°C

FLUID PROPERTIES		method	limit/base	current	history1	history2
pH	Scale 0-14	ASTM D1287*		**9.59**	9.38	9.49
Visc @ 40°C	cSt	ASTM D7279(m)		▲ **33.2**	▲ 33.5	▲ 33.7
