PROBLEM SUMMARY

Area
Site Services - TEMTEMMD
Machine Id
N/A TM-465-315-501 #2 Allis Chalmers Compressor Motor
Component
Non-Drive End Bearing
Fluid
ESSO NUTO H ISO 32 (1000 LTR)

OIL ANALYSIS REPORT

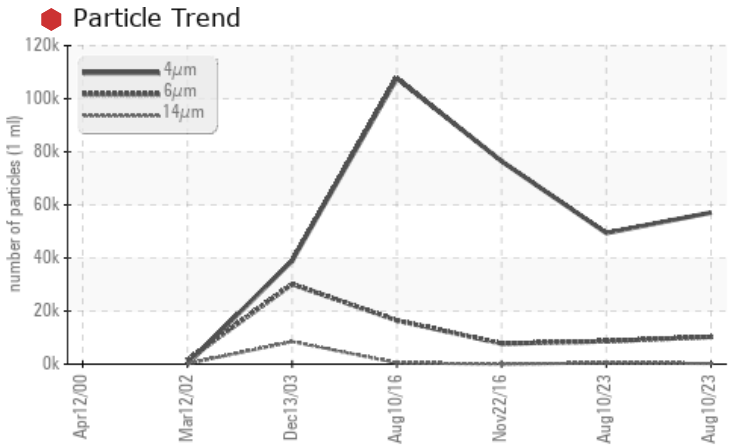
COMPONENT CONDITION SUMMARY

Sample Status				SEVERE	SEVERE	SEVERE
Particles >6µm		ASTM D7647	>320	**8642**	10296	7726
Particles >14µm		ASTM D7647	>80	**429**	244	54
Particles >21µm		ASTM D7647	>20	**116**	45	5
Particles >38µm		ASTM D7647	>4	**10**	1	0
Oil Cleanliness		ISO 4406 (c)	>--/15/13	**23/20/16**	23/21/15	23/20/13

There is a high amount of particulates (2 to 100 microns in size) present in the oil. The water content is negligible. The system cleanliness code is much higher than the acceptable limit for the target ISO 4406 cleanliness code.

We advise that you check all areas where contaminants can enter the system. We advise that you perform a filter service, and use off-line filtration to improve the cleanliness of the system fluid. The air breather requires service. If unrated, we recommend that you replace with a suitable micron rated and/or desiccant air breather. If rated, we recommend that you service/replace the breather. Resample in 30-45 days to monitor this situation. Please contact your representative for information regarding the proper sampling kits for your service. NOTE: We recommend using IND 3 test kits, this testkit includes Analytical Ferrography which provides a detailed morphological analysis of wear particles present in the fluid.

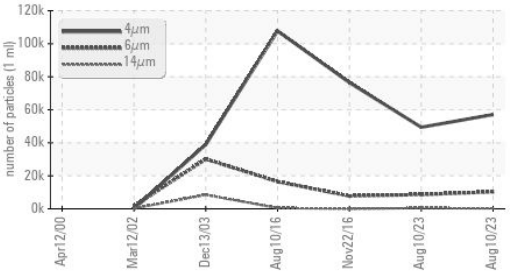
Particle Trend

FLUID CLEANLINESS		method	limit/base	current	history1	history2
Particles >4µm		ASTM D7647		**49392**	57082	76446
Particles >6µm		ASTM D7647	>320	**8642**	10296	7726
Particles >14µm		ASTM D7647	>80	**429**	244	54
Particles >21µm		ASTM D7647	>20	**116**	45	5
Particles >38µm		ASTM D7647	>4	**10**	1	0
Particles >71µm		ASTM D7647	>3	**1**	0	0
Oil Cleanliness		ISO 4406 (c)	>--/15/13	**23/20/16**	23/21/15	23/20/13

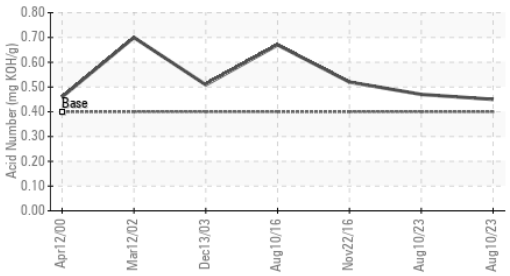
The AN level is acceptable for this fluid. The oil is still serviceable provided that the contaminant(s) can be reduced to acceptable levels.

FLUID DEGRADATION		method	limit/base	current	history1	history2
Acid Number (AN)	mg KOH/g	ASTM D974*	.40	**0.45**	0.47	0.52
