Area
Societe via Quebec City - 888017
Machine Id
XB097
Component
Hydraulic System
Fluid
NOT GIVEN (--- GAL)

Customer Id: CHECOB
Sample No.: E30000069
Lab Number: 02576334
Test Package: IND 2

OIL ANALYSIS REPORT

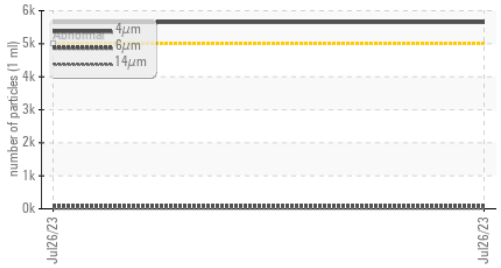
Particle Trend

Contamination
Particles >4µm and oil cleanliness are notably high.

FLUID CLEANLINESS		method	limit/base	current	history1	history2
Particles >4µm		ASTM D7647	>5000	▲ **5651**	---	---
Particles >6µm		ASTM D7647	>1300	**97**	---	---
Particles >14µm		ASTM D7647	>160	**9**	---	---
Particles >21µm		ASTM D7647	>40	**2**	---	---
Particles >38µm		ASTM D7647	>10	**0**	---	---
Particles >71µm		ASTM D7647	>3	**0**	---	---
Oil Cleanliness		ISO 4406 (c)	>19/17/14	▲ **20/14/10**	---	---
