PROBLEM SUMMARY

Area
C13100 - GFL 122 Arrow Road
Machine Id
AG182
Component
Hydraulic System
Fluid
NOT GIVEN (--- GAL)

OIL ANALYSIS REPORT

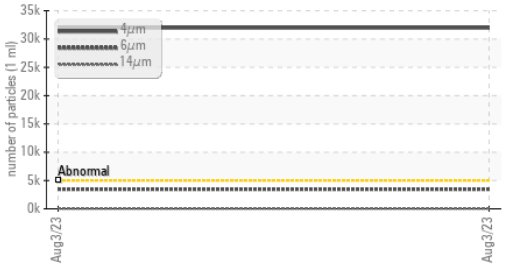
Particle Trend

Contamination
Particles >4µm are abnormally high. Particles >6µm and oil cleanliness are abnormally high.

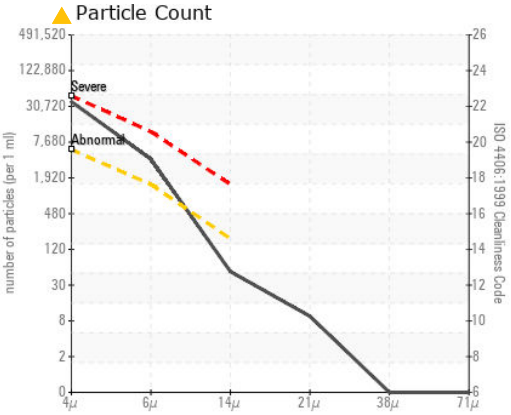
Particle Count

FLUID CLEANLINESS		method	limit/base	current	history1	history2
Particles >4µm		ASTM D7647	>5000	▲ **31964**	---	---
Particles >6µm		ASTM D7647	>1300	▲ **3461**	---	---
Particles >14µm		ASTM D7647	>160	**45**	---	---
Particles >21µm		ASTM D7647	>40	**8**	---	---
Particles >38µm		ASTM D7647	>10	**0**	---	---
Particles >71µm		ASTM D7647	>3	**0**	---	---
Oil Cleanliness		ISO 4406 (c)	>19/17/14	▲ **22/19/13**	---	---
